TENTATIVELY SELECTED PLAN

BIOLOGICAL ASSESSMENT - SAN JUAN HARBOR IMPROVEMENT STUDY

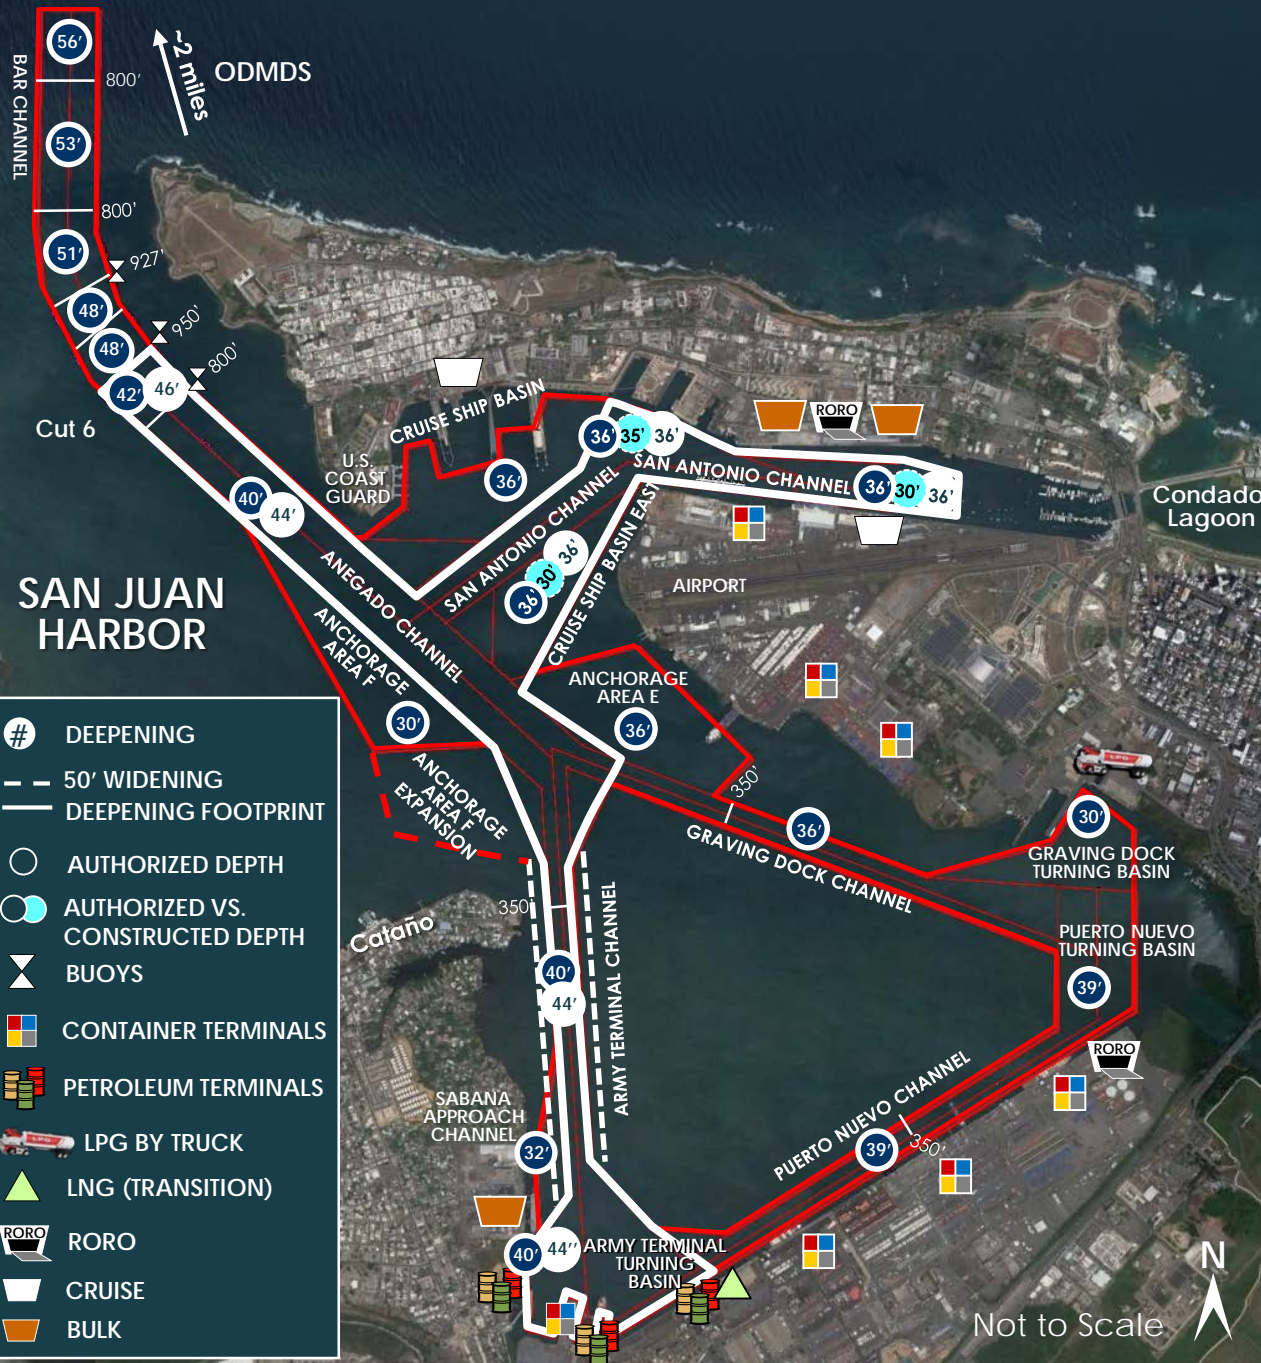
WIDENING

- Widen Army Terminal Channel from 350' to 450' maximum

DEEPENING (counterclockwise)

- Cut 6 to 46'
- Anegado Channel to 44'
- Army Terminal Channel to 44'
- Army Terminal Turning Basin to 44'
- San Antonio Channel to 36'
- Cruise Ship Basin East to 36'

CONSTRUCTION

- Mechanical clamshell dredge with bottom-dump barge transport to offshore Ocean Dredged Material Disposal Site (ODMDS)
- ~ 2.1M cubic yards of material

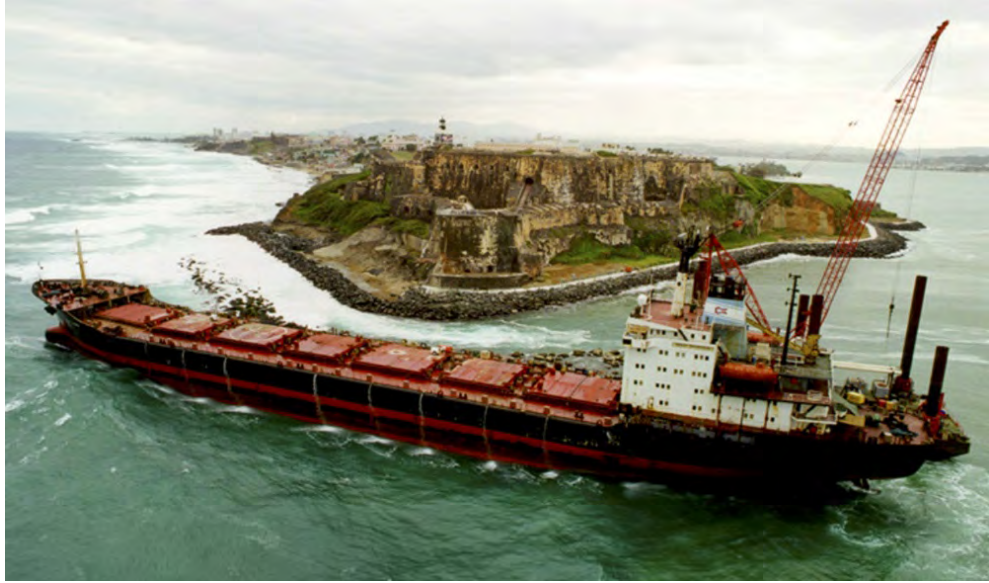
Figure 2 - M/V Sergo Zakariadze Grounding – November 1999 (U.S. Coast Guard)

SJH is known to have many groundings, allisions and collisions. Some of these groundings have occurred at the mouth of the entrance channel where there is the potential for hardbottom resources to be present (Figure 2 and Figure 3). The entrance channel also presents significant navigational challenges including bar channel winds and waves causing ships to roll and heel and winds, waves and currents in the entrance channel cause ships to alter their speed resulting in squat and sinkage. Changes in the entrance channel proposed by this project will help to improve these conditions for vessels transiting the entrance channel.

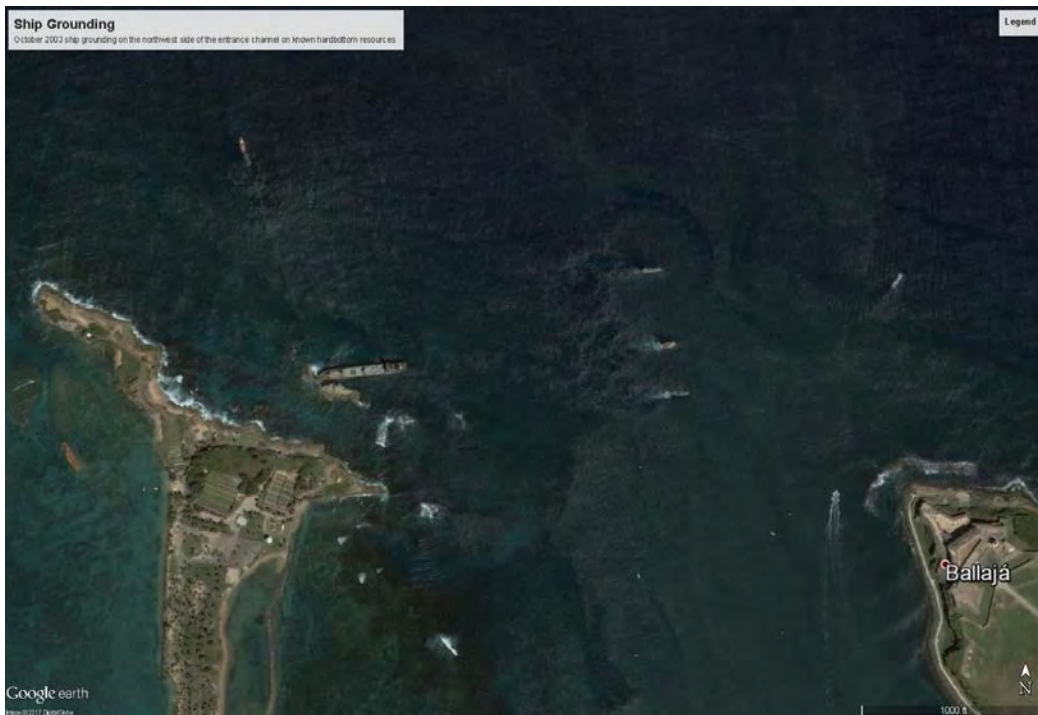
Figure 3 - Unknown Ship Grounding Northwest side of Entrance Channel October 2003

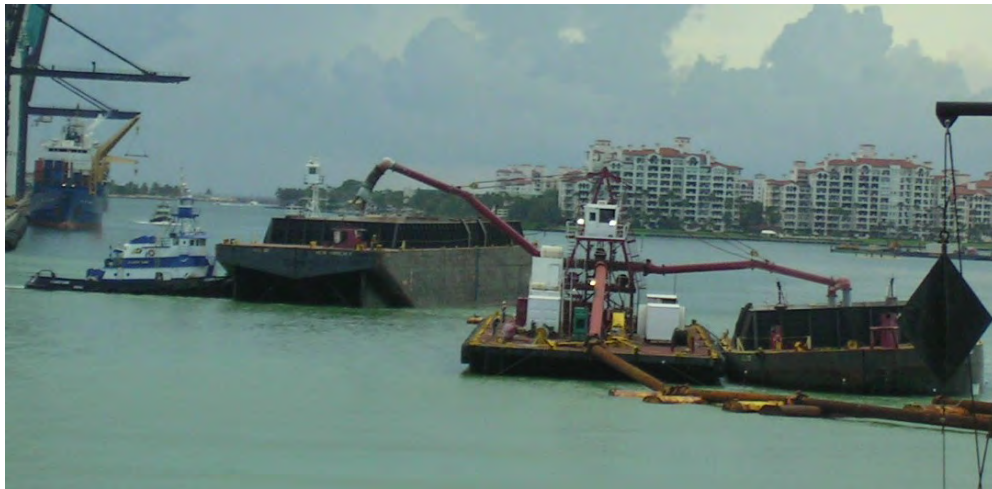
Figure 7 - A spider barge loading material into two scows from the cutterhead dredge, Texas, during Miami Harbor Phase II 2005-2006.

A large cutterhead dredge could be used for the entire SJH project. Disposal options include transport by barges to the ODMDS or placement of dredged in previously dredged holes as part of the Condado Lagoon beneficial use of dredged material/seagrass restoration project. When the material will be taken to the ODMDS, the material may be loaded into scows using a barge known as a spider barge. This barge allows for one scow to be loaded and a second to begin loading immediately after the first is complete, ensuring more efficient dredging due to lessened down time waiting for scows to return from the ODMDS (Figure 7).

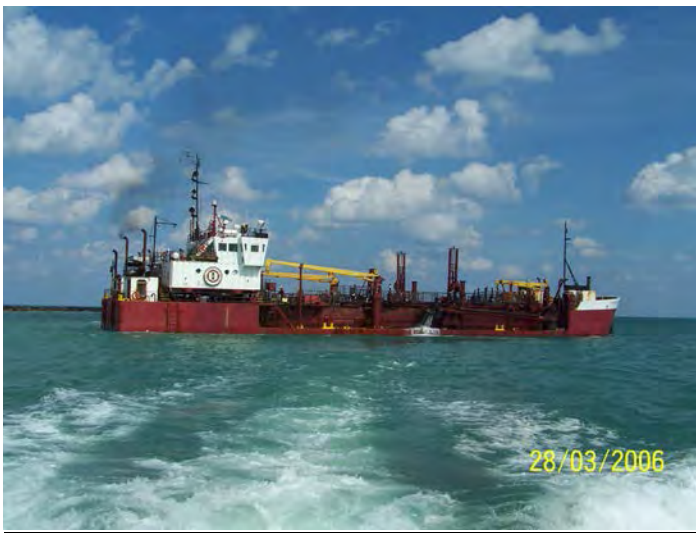
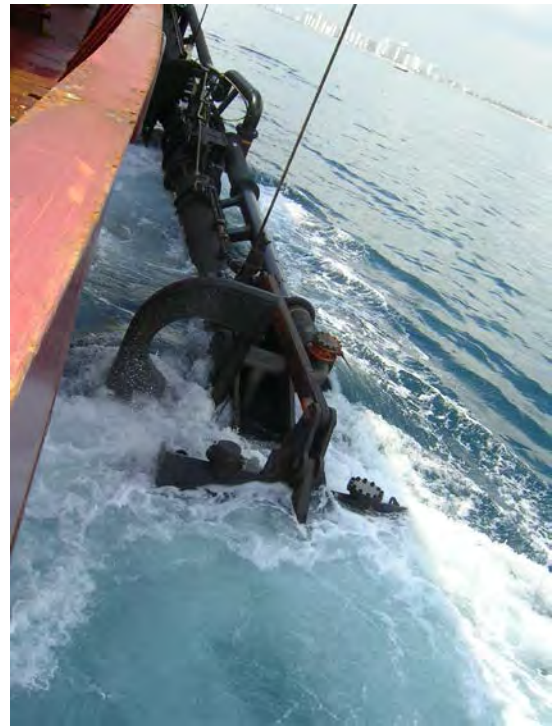
Figure 8 - Hopper dredge and dragarm being lowered into the water (Video of hopper dredge - <http://el.erdc.usace.army.mil/dots/doer/anima/turtle.avi>)

opening called a draghead for contact with the bottom (Figure 8). Depending on the hopper dredge, a slurry of water and sediment is generated from the plowing of the draghead “teeth,” the use of high pressure water jets, and the suction velocity of the pumps. The dredged slurry is distributed within the vessels hopper allowing for solids to settle out and the water portion of the slurry to be discharged from the vessel during operations through its overflow system. When the hopper attains a full load, dredging stops, the dragarms are lifted off the bottom and the ship travels to an in-water disposal site, where the dredged material is discharged through the bottom of the ship by splitting the hull, or opening doors located in the bottom of each hopper.

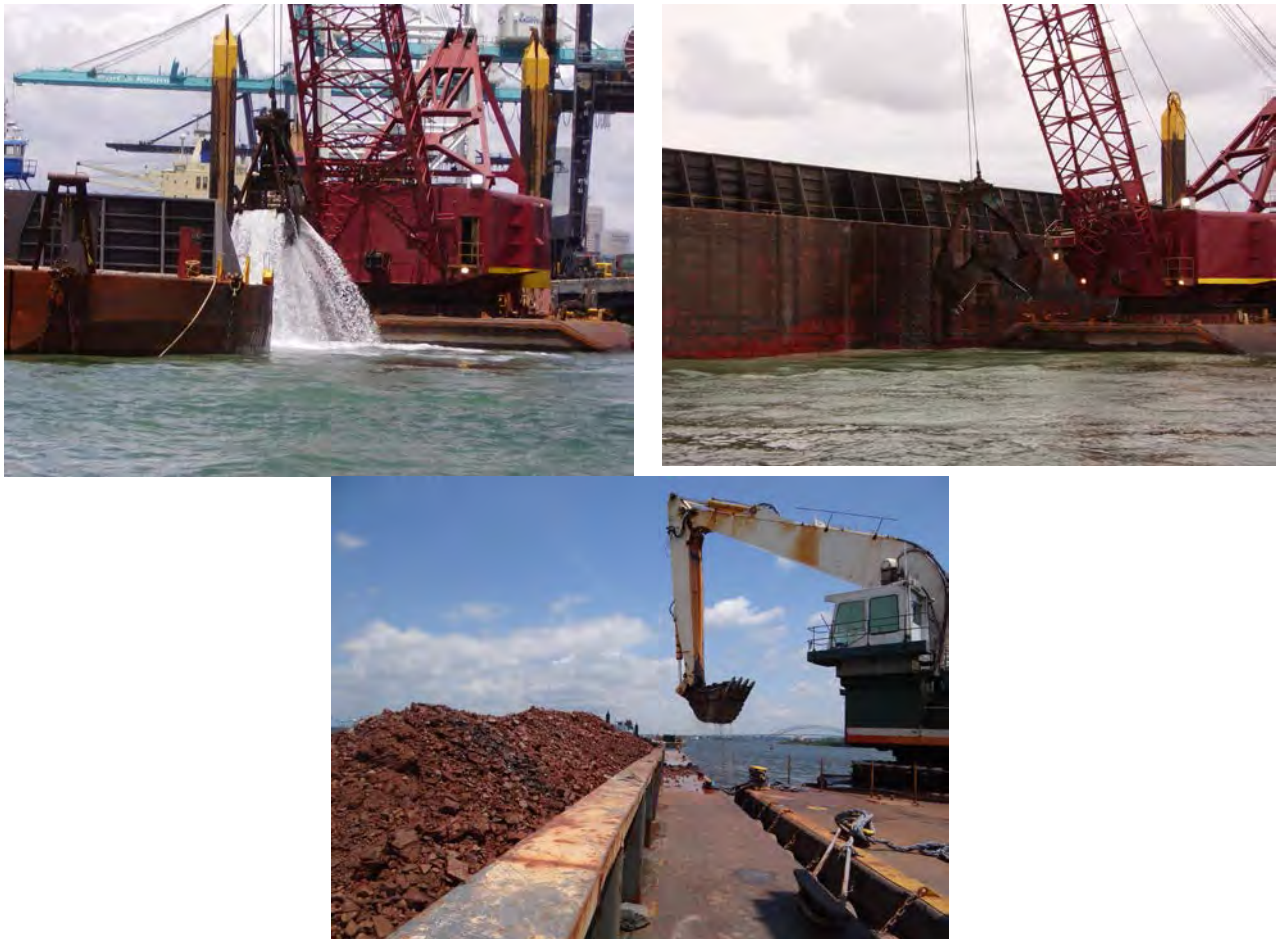
Figure 9 - Mechanical dredges (clamshell bucket/back-hoe dredge and barge). (Video of clamshell dredge - <http://el.erdc.usace.army.mil/dots/doer/anim/clamshel.avi>.)

Mechanical dredges are characterized by the use of some form of bucket to excavate and raise the bottom material (Figure 9). They remove material by scooping it from the bottom and then placing it onto a waiting barge/scow or directly into a placement/disposal area. Mechanical dredges work best in consolidated, or hard-packed, materials and can be used to clear rocks and debris. Dredging buckets have difficulty retaining loose, fine materials, which can be washed from the bucket as it is raised. Special buckets have been designed for controlling the flow of water and material from buckets and are used when dredging contaminated sediments. Mechanical dredges are rugged and can work in tightly confined areas. They are mounted on a large barge and are towed to the dredging site and secured in place by anchors or spuds. They are often used in harbors, around docks and piers, and in relatively protected channels, but are not suited for areas of high traffic or rough seas.

The backhoe dredge is essentially a power shovel mounted on a barge. The backhoe digs toward the machine with the bucket penetrating from the top of the cut face. The operation cycle is similar to the clamshell dredge, as are the factors affecting production. Backhoe marine excavators have accurate positioning ability and are able to excavate firm or consolidated materials. However, they are susceptible to swells and have low to moderate production. Backhoe marine excavators could be used to excavate unconsolidated overburden, fractured rock, and possibly some unfractured rock.

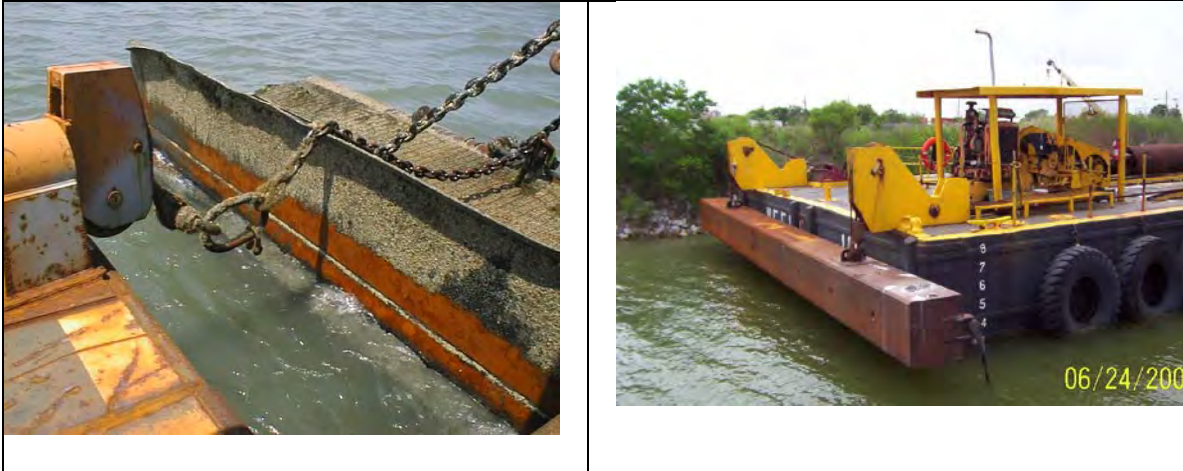
Figure 10 - Example bed levelers and associated operating conditions (photographs courtesy Bean Dredging Company and Weeks Marine Incorporated)

A “bed-leveler” is considered to be any type of dragged device used to smooth sediment bottom irregularities left by a dredge (Figure 10). It is also referred to as a “mechanical leveling device or drag bar”. In various parts of the U.S. this process is known as “barring” or “knockdown” (Hales et al. 2003). In certain cases, bed-levelers are used to redistribute sediments to maintain navigable depths rather than removing them by dredging with conventional methods. Dredge types using bed-levelers include clamshell (excavator), bucket, hydraulic cutterhead, and hopper dredges. Bed levelers do not use suction and redistribute sediments, rather than removing them. Plows, I-beams or other seabed leveling mechanical dredging devices are often used to lower high spots left in channel bottoms and dredged material deposition areas by hopper dredges or other types of dredges.

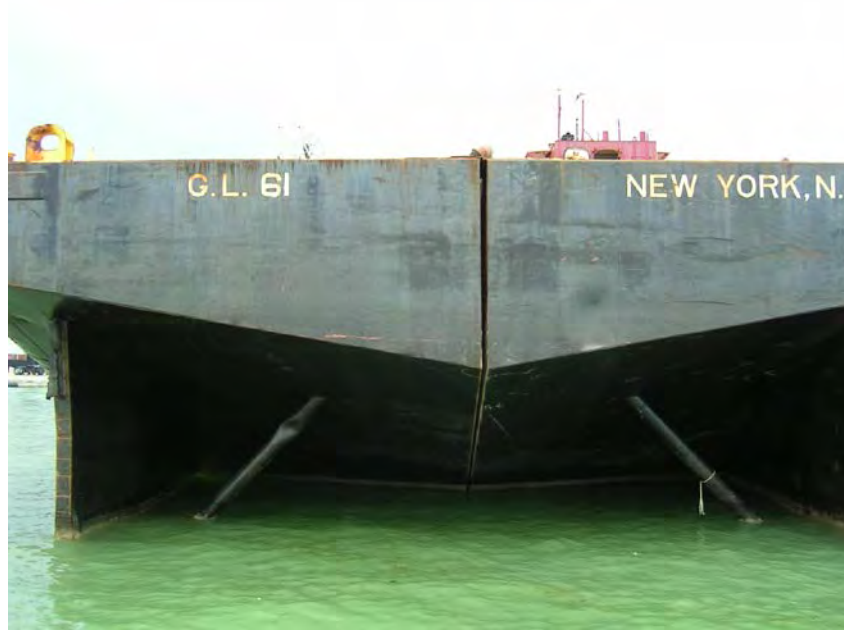
Figure 11 - Split-hull barge

A split hull barge (Figure 11) has two hulls connected with hinges at the front and back. The two-door hinged configuration, allows the hulls to swing apart, opening at the bottom to allow dredged material to fall from the barge. This provides a rapid disposal of dredged material, which, as a result, is placed within a small area. The rapid descent of material through the water column reduces the potential for resuspension of sediments into the water column during disposal. Such a barge may be used for ODMDS disposal. A rubber seal (similar to a gasket or weather-stripping on a door), is pinched between the two doors, limiting the leakage from the barge of water and dredged material. This seal does not prevent 100% of water and dredged material from leaking; however it minimizes it to the maximum extent practicable.

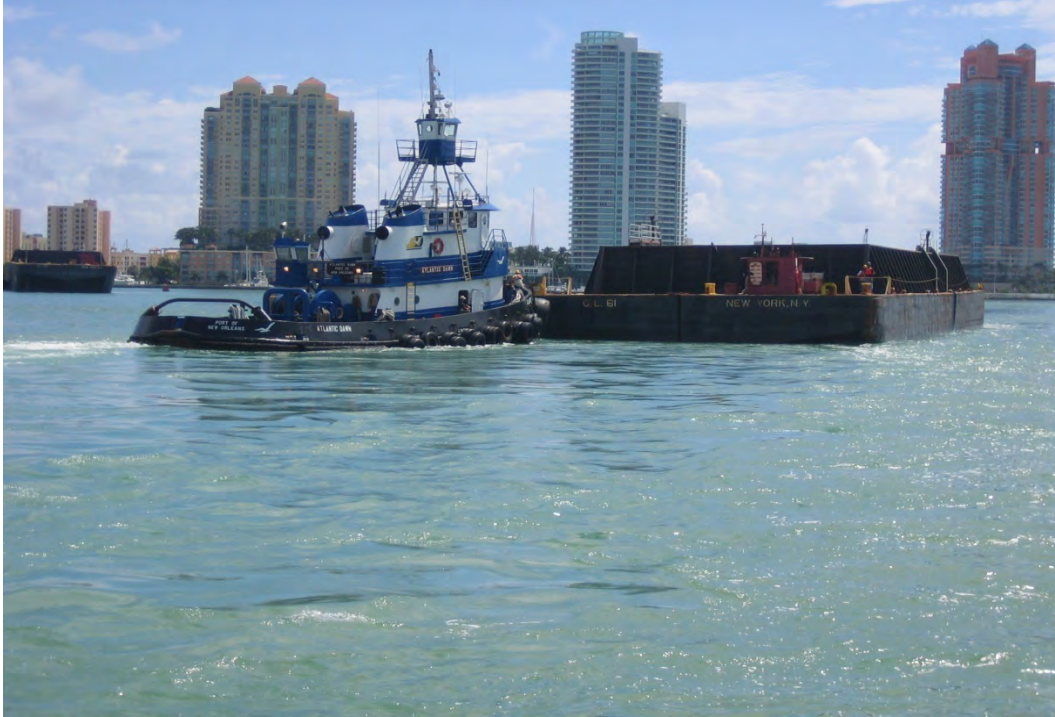
Figure 12 - Split Hull Barge Being Pushed by Tug

All three barge types are typically pushed or pulled to the disposal site by a tug (Figure 12) and for split hull and bottom dump barge, the disposal action is triggered remotely from the tug to the barge. The exact time the signal is given to the barge, and when the doors open and close are recorded in a tracking system for further data analysis and compliance tracking.

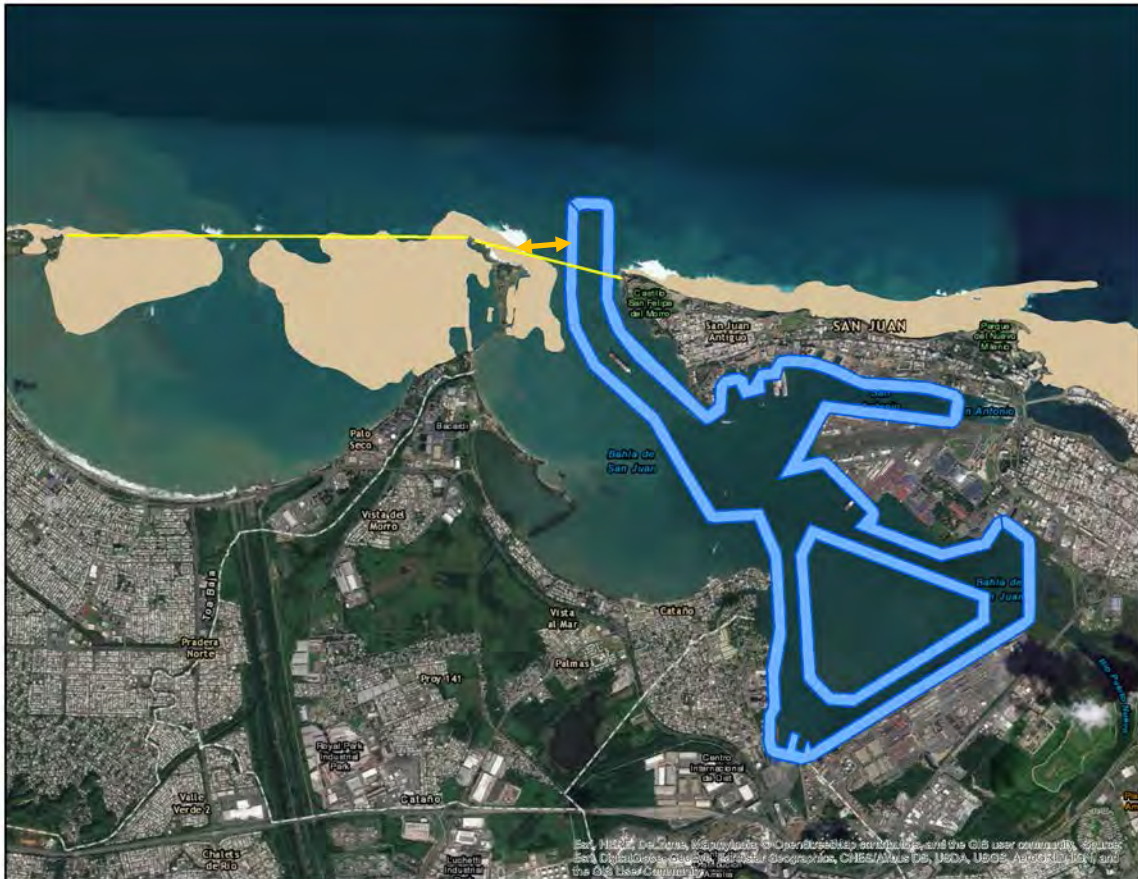
Figure 19 - Mapped hardbottom and reef habitat in the vicinity of the San Juan Harbor- the yellow line is the COLREGS line. Habitats inside the line within the bay are not considered critical habitat for *Acropora* spp.

review and final critical habitat designation, NMFS has determined that any hardground habitat located in the Puerto Rico in waters less than 30 meters deep, beyond the COLREGS line (outside of the harbor entrance) have the potential to support either of the *Acropora* species (NMFS 2005). The final critical habitat determination identifies that the primary constituent elements (PCEs) for the continued survival of Acroporid species (NMFS 2008b). The closest hardbottom/reef habitat that may have the necessary PCEs is 1,700 feet to the west of the channel, denoted by the orange arrow (Figure 19).

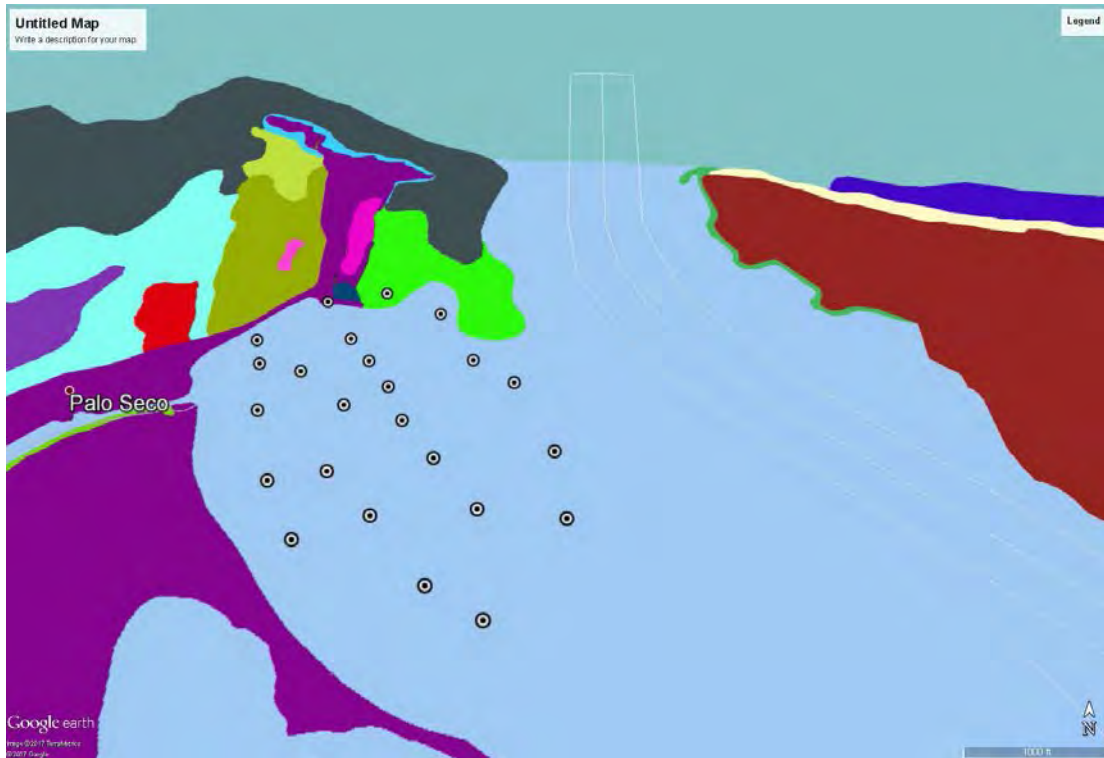
Figure 20 - NOAA 2001 Habitat Classification Layer of San Juan Harbor Entrance Channel

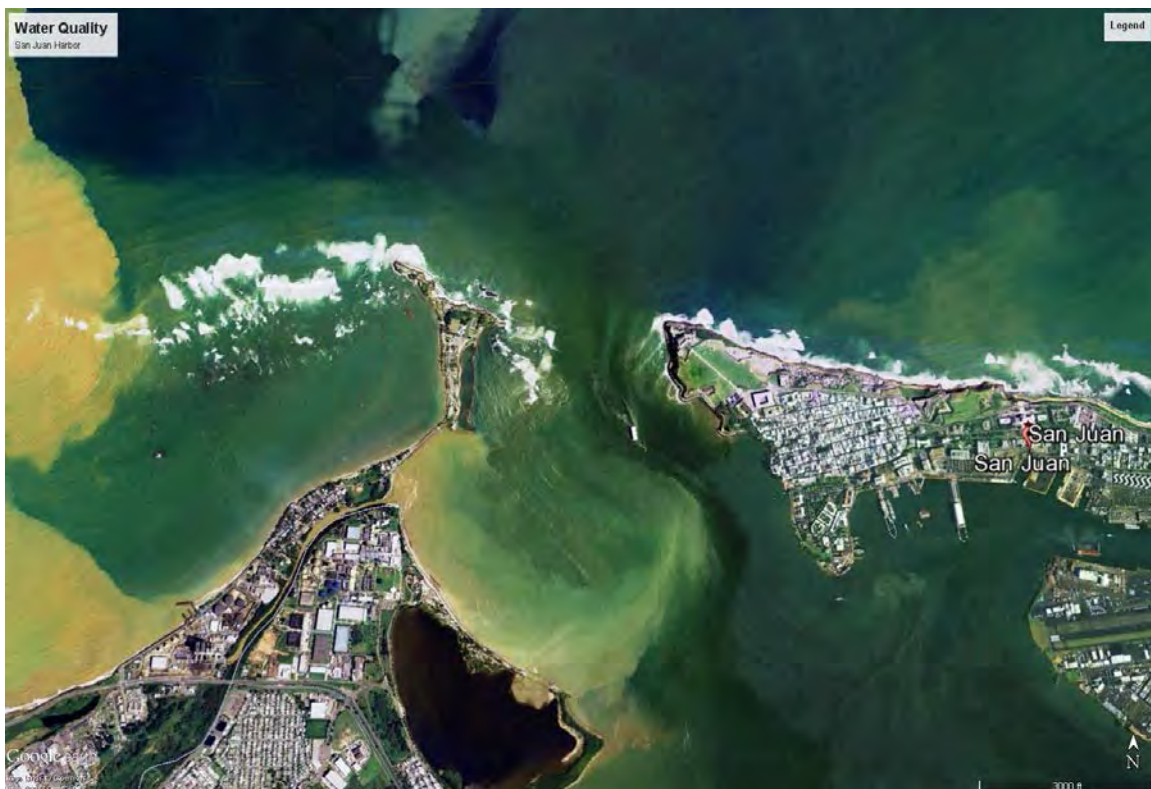
Figure 23 - October 2004 Aerial Photo of Sediment Input to Marine Environment from Upland Sources (Google Earth).

Examples of this large sediment load are seen during rain events where large amounts of terrigenous sediments enter San Juan bay and surrounding waters (Figure 23) from the large flood control project located in the embayment to the west of the harbor, and from the Rio de Bayamon on the west side of the harbor, south of Isla de Cabras.

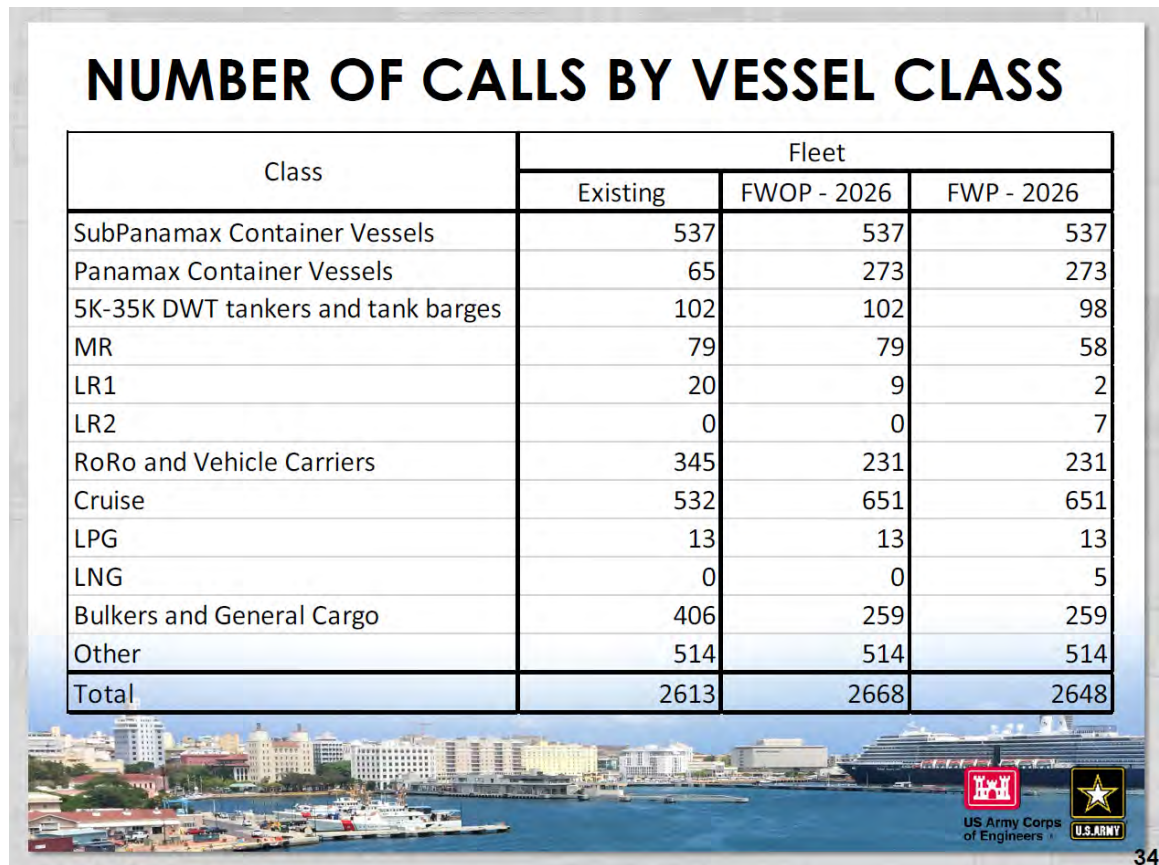
Figure 29 - Number of Vessel Calls. Existing Fleet vs Future without Project and Future with Project in 2026.

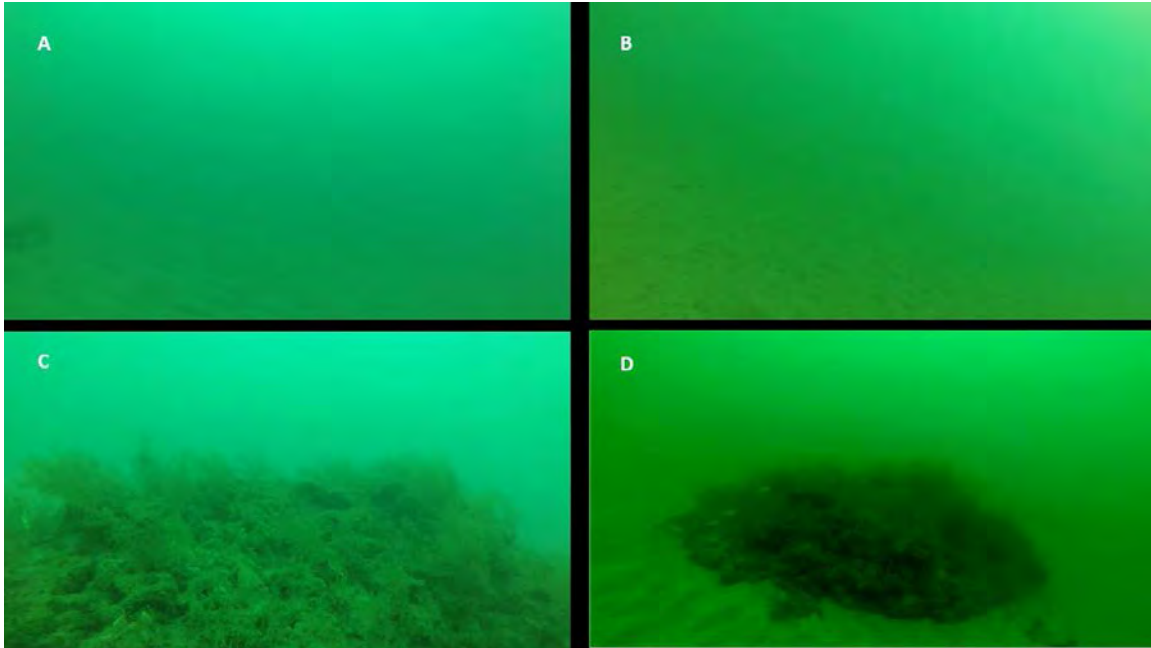
Figure 32 - Photos from video transect 209 on January 30, 2016. A and B. Sand. C and D. Algae patch on limestone rock surrounded by sand. Four fish likely to be *Lutjanus synagris* (Lane snapper).

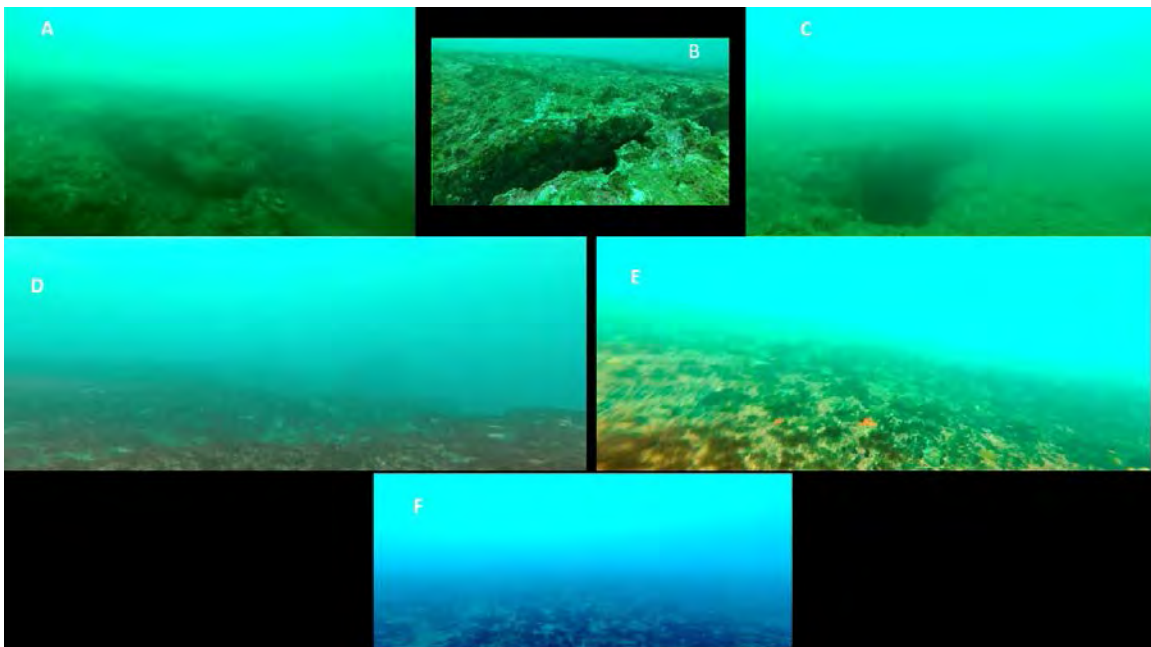
Figure 33 - Photos from video transect 210 on Jan. 30, 2016. A, B and C. Limestone ledges and crevices at approximately 17 to 30 ft. depth. These crevices and ledges are inhabited by *Diadema antillarum*, *Thalassoma bifasciatum*, algae and sponges.

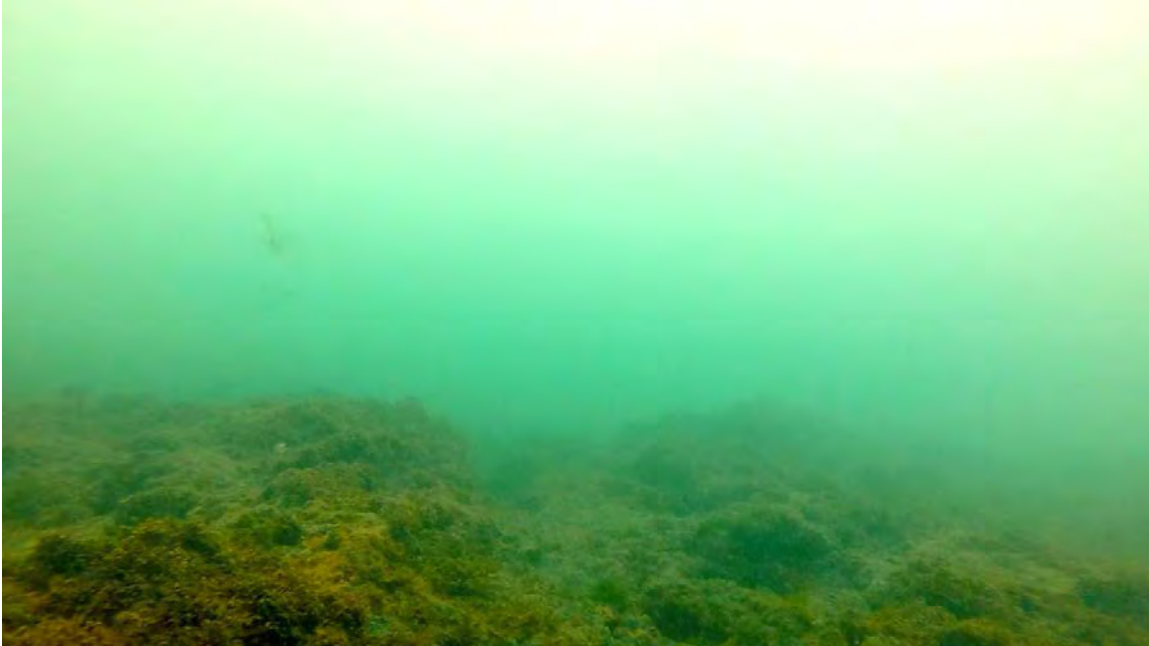
Figure 34 - Photo from video transect 212 on Jan. 30, 2016. Depth is 7 ft. Brown algae over limestone.

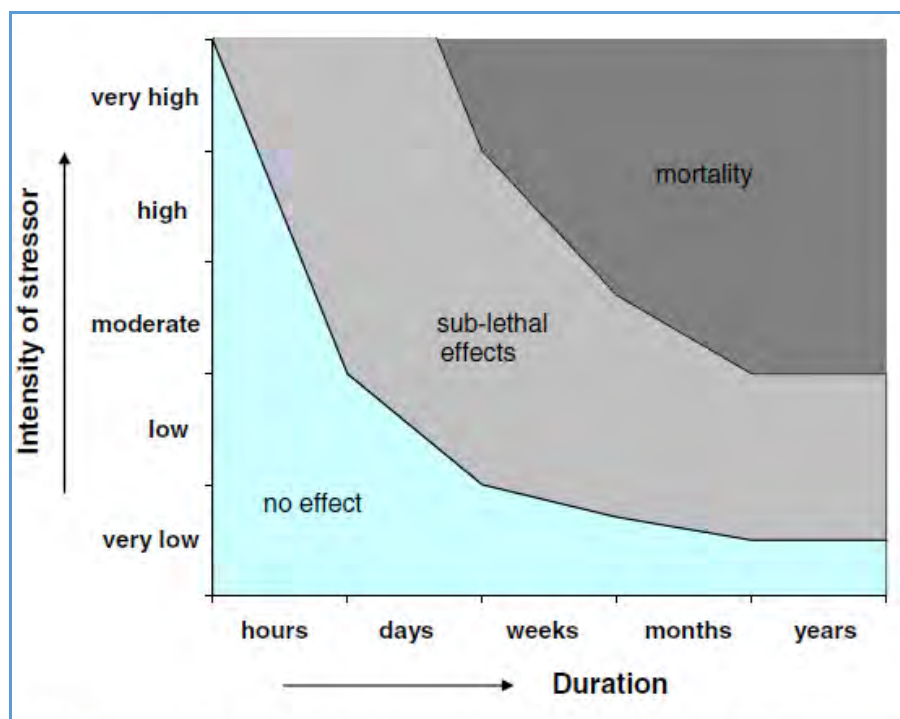
Figure 35 - Figure 2 from Erftmeijer et al 2012. Intensity of Stressor vs Duration

Although these effects from sedimentation can occur naturally due to increase runoff from rain or sedimentation associated with tropical storms (Blair et al. 1994), they are also likely to occur in close physical proximity to dredging. The intensity of effect is dependent upon the intensity and duration of the stressor (Figure 35).

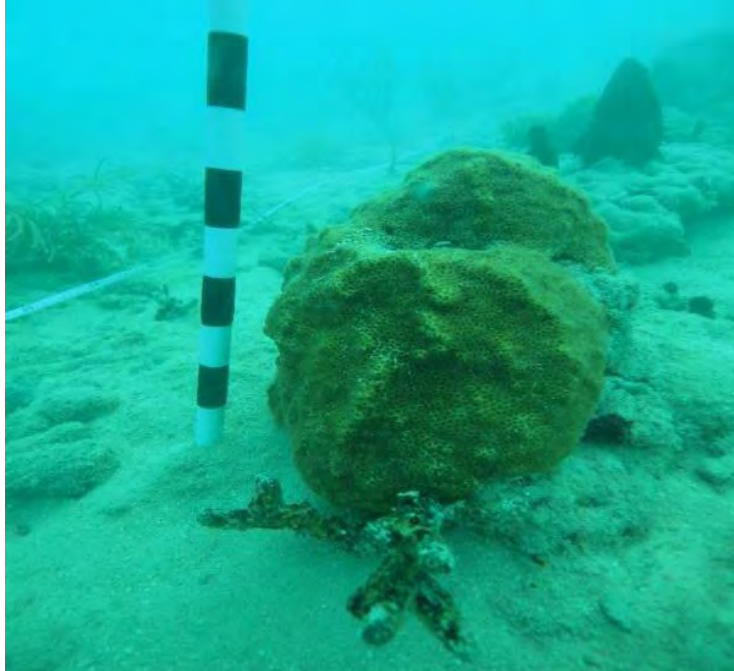
Figure 37 - S. bournoni colony at R2S-400, Miami Harbor. Photo was taken on May 21, 2015

Corals with a flatter morphology or corals which are located in a depression in the reef structure where material can accumulate, tended to have more difficulty shedding accumulated sediment, often ending up part of the colony unable to be unburied, and the long term exposure of that portion of the colony to the sediment resulting in partial mortality (Figure 36). While this may not lead to total mortality of the colony, it would result in stress to the colony as a whole. Taller corals were able to shed the excess sediment and did not exhibit the partial mortality signature seen in the flatter corals (Figure 37).

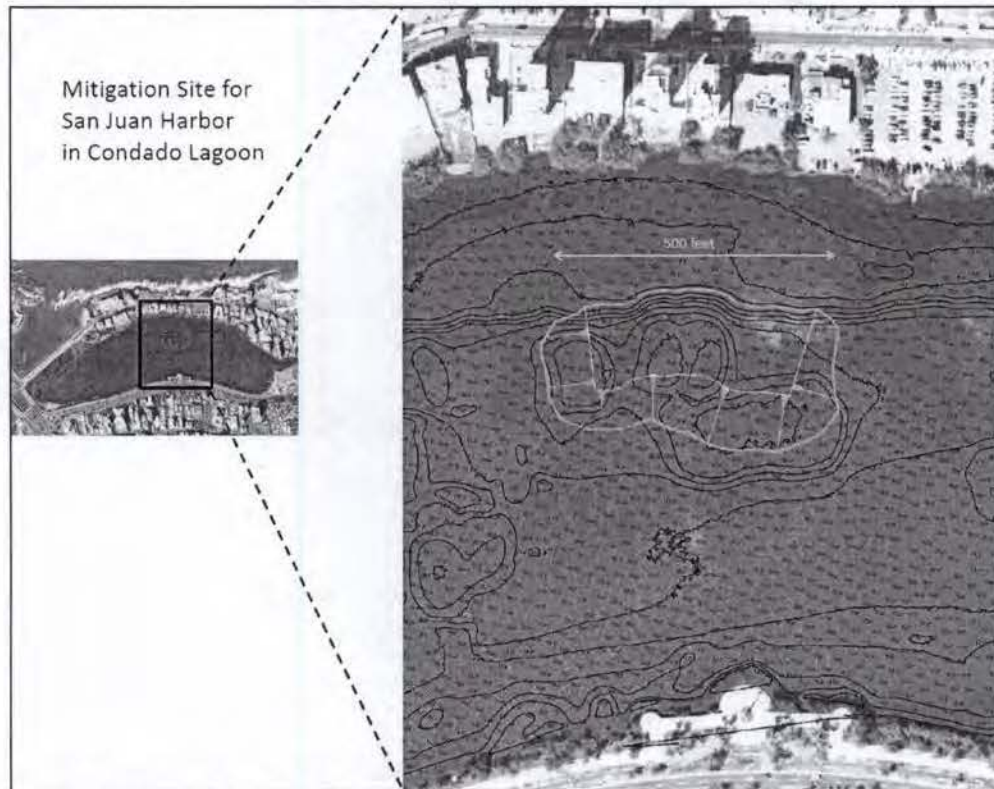
Figure 2. Figure from DEA showing the proposed location of the dredged pit that will be filled under the new mitigation plan (USACE 2014)

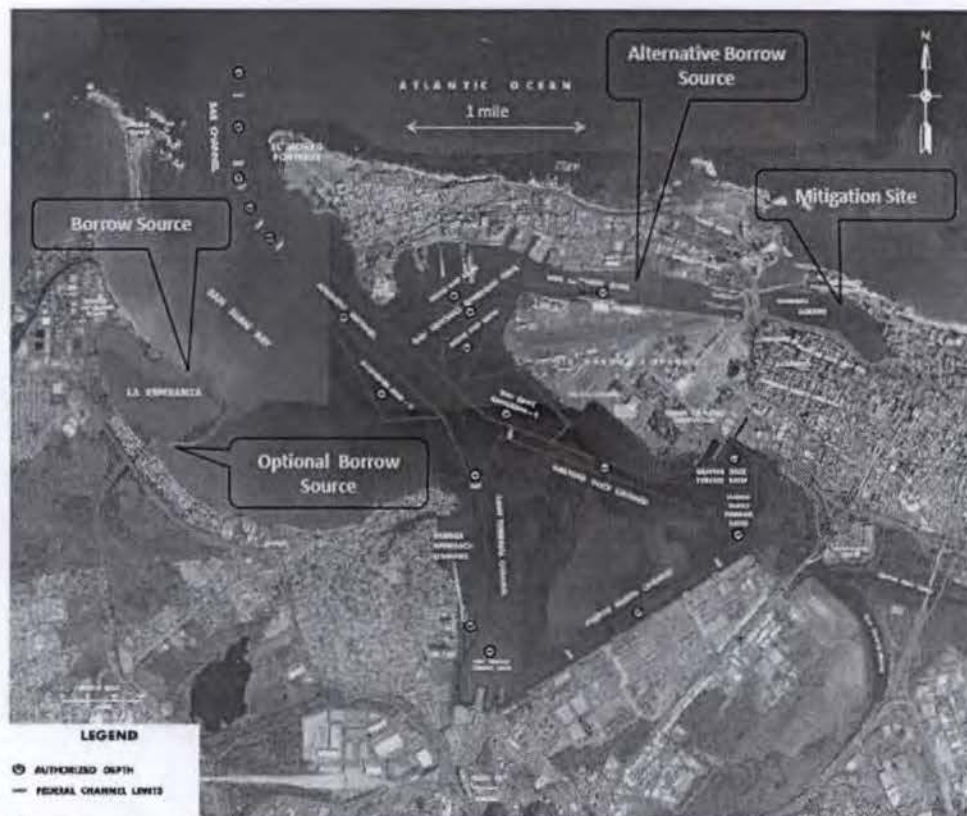
Figure 3. Figure from DEA showing the locations of the borrow sites (the alternative borrow source in San Antonio Channel is no longer proposed) and fill area in the lagoon (USACE 2014)
