**Biological Evaluation Study. Proposed Emergency Shoreline Protection Measure.  
Asociación Condómines Azure Beach, San Juan, Punta Las Marías, Puerto Rico.**

## 1 Introduction

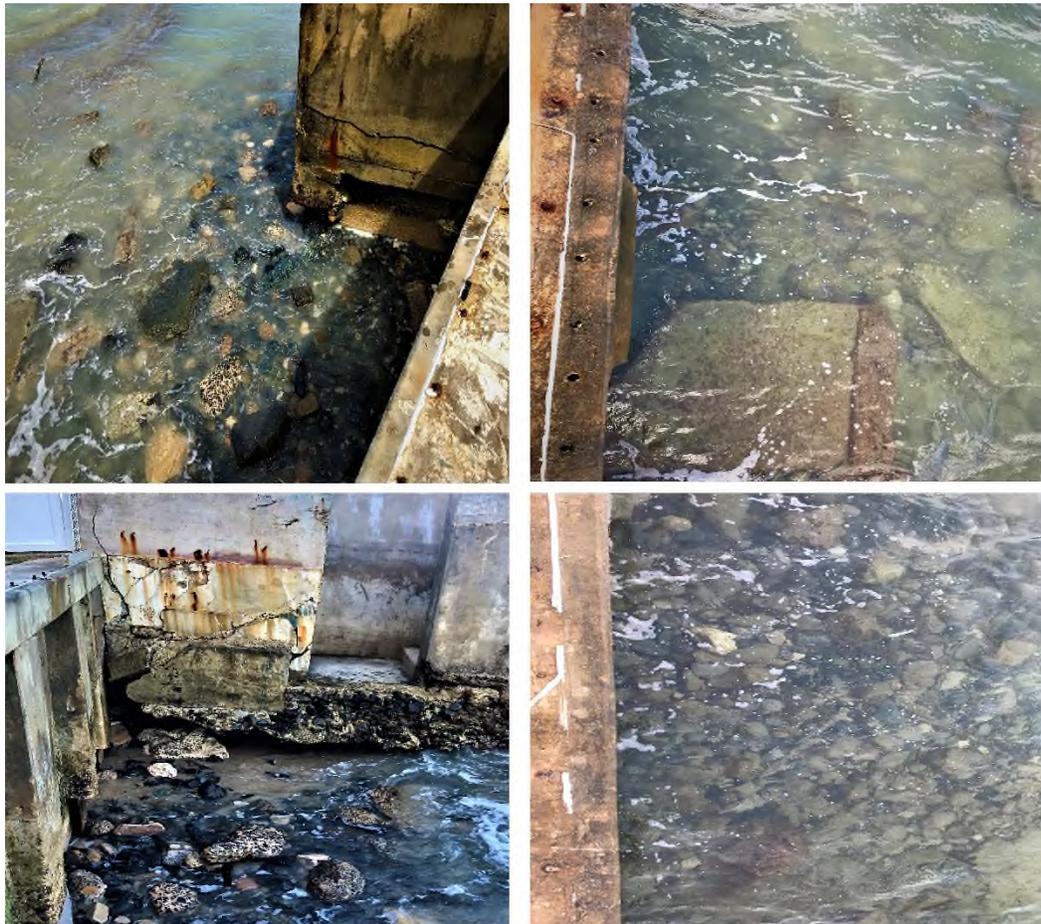
shore. This area is described as relative flat bottom with gentle slopes, with medium grain sand near the existing seawall, and fine silt/mud (unconsolidated sediments) north of the line of armor stone (remnants from the former wall), covering around 20%. Based on historical photographs, the alignment of the armor stone coincides with the former seawall that appears to have failed over 25 years ago. Water depth ranged from 1-ft. to 7-ft. Marine bottom cover is 95% not colonized and 5% colonized by encrusting brown algae. Light penetration is partially restricted due to turbidity. This reach of shoreline has been well documented over the years and although at the time of the survey it was covered by a sand veneer, recent photographs clearly reveal that the area where the revetment is proposed is primarily weathered stones and concrete debris (see Figure 1).

**Figure 1. Rock, weathered stone, and concrete debris substrate throughout area seaward of existing seawall where revetment is proposed.**

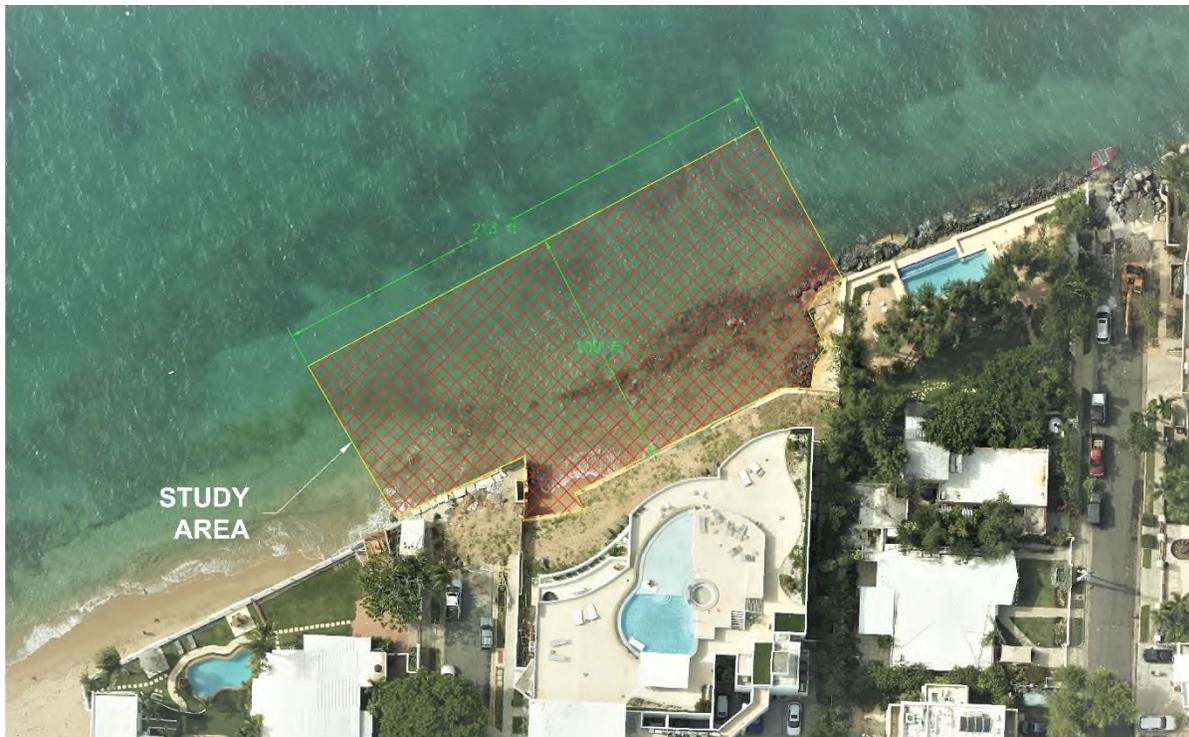
The biological evaluation was performed by marine scientists trained in biological resource and habitat identification. Field activities in support of the benthic characterization included a qualitative survey method. The baseline benthic characterization was conducted within a total study area of 100 x 213 feet (Figure 2).

**Figure. 2- Project Footprint area surveyed showing 100 x 213 feet.**

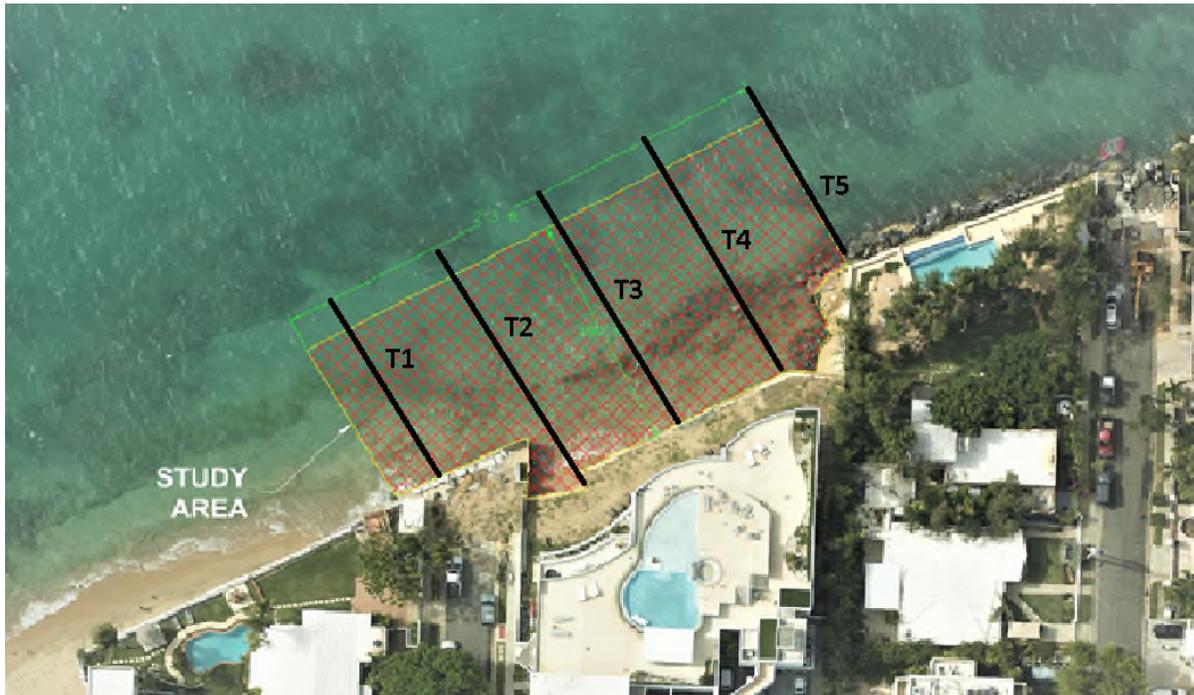
Biotic parameters were measured to characterize benthic composition and structure. The contents of each transect placement were visually inspected and assigned a percent cover value. Percent cover values were based on two-dimensional, broad-cover estimations describing the total transect area when viewed from directly above for cumulative biotic cover and individually for each parameter of interest (Figure 3).

**Figure 3- Showing Transects Location**

Transect	Max Depth (ft)	Description	Coordinates
T1	7	100 % sand	18°27'13.55" N 66°02'31.64" W
	1		18°27'13.03" N 66°02'31.374" W
T2	7	100 % sand	18°27'13.63" N 66°02'31.09" W
	1		18°27'13.03" N 66°02'30.81" W
T3	6	75 % sand/ 25 % boulders	18°27'13.82" N 66°02'30.59" W
	1		18°27'13.27" N 66°02'30.32" W
T4	7	80% sand/ 20% boulders	18°27'13.94" N 66°02'30.23" W
	1		18°27'13.50" N 66°02'29.84" W
T5	7	70% sand /30% boulders	18°27'14.22" N 66°02'29.82" W
	1		18°27'13.91" N 66°02'29.66" W
