SAN JUAN HARBOR, PUERTO RICO NAVIGATION IMPROVEMENTS STUDY

Final Integrated Feasibility Report & Environmental Assessment

APPENDIX G USFWS ESA FWCAR Consultation

Final FISH AND WILDLIFE COORDINATION ACT REPORT

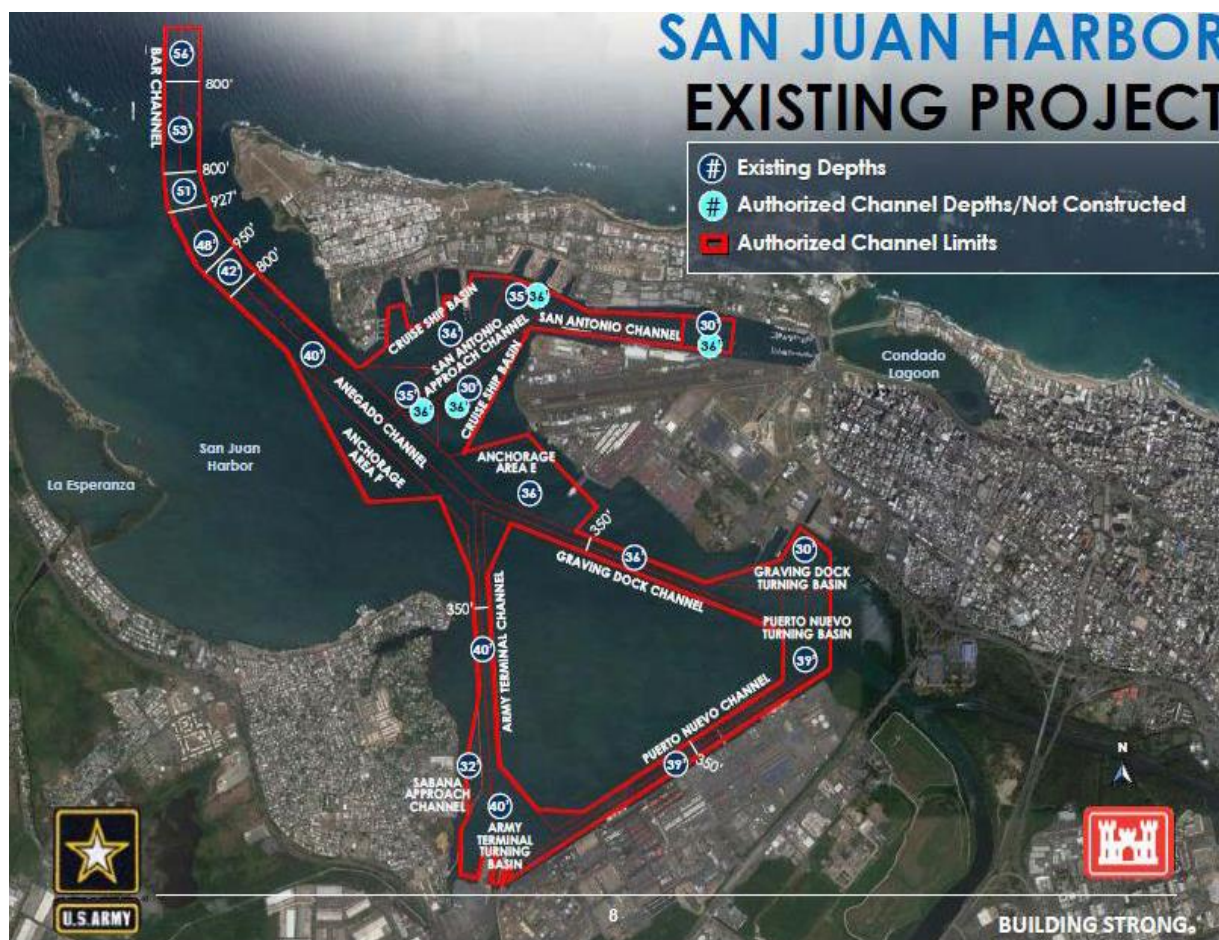
Figure 1. Existing conditions San Juan Harbor Project.

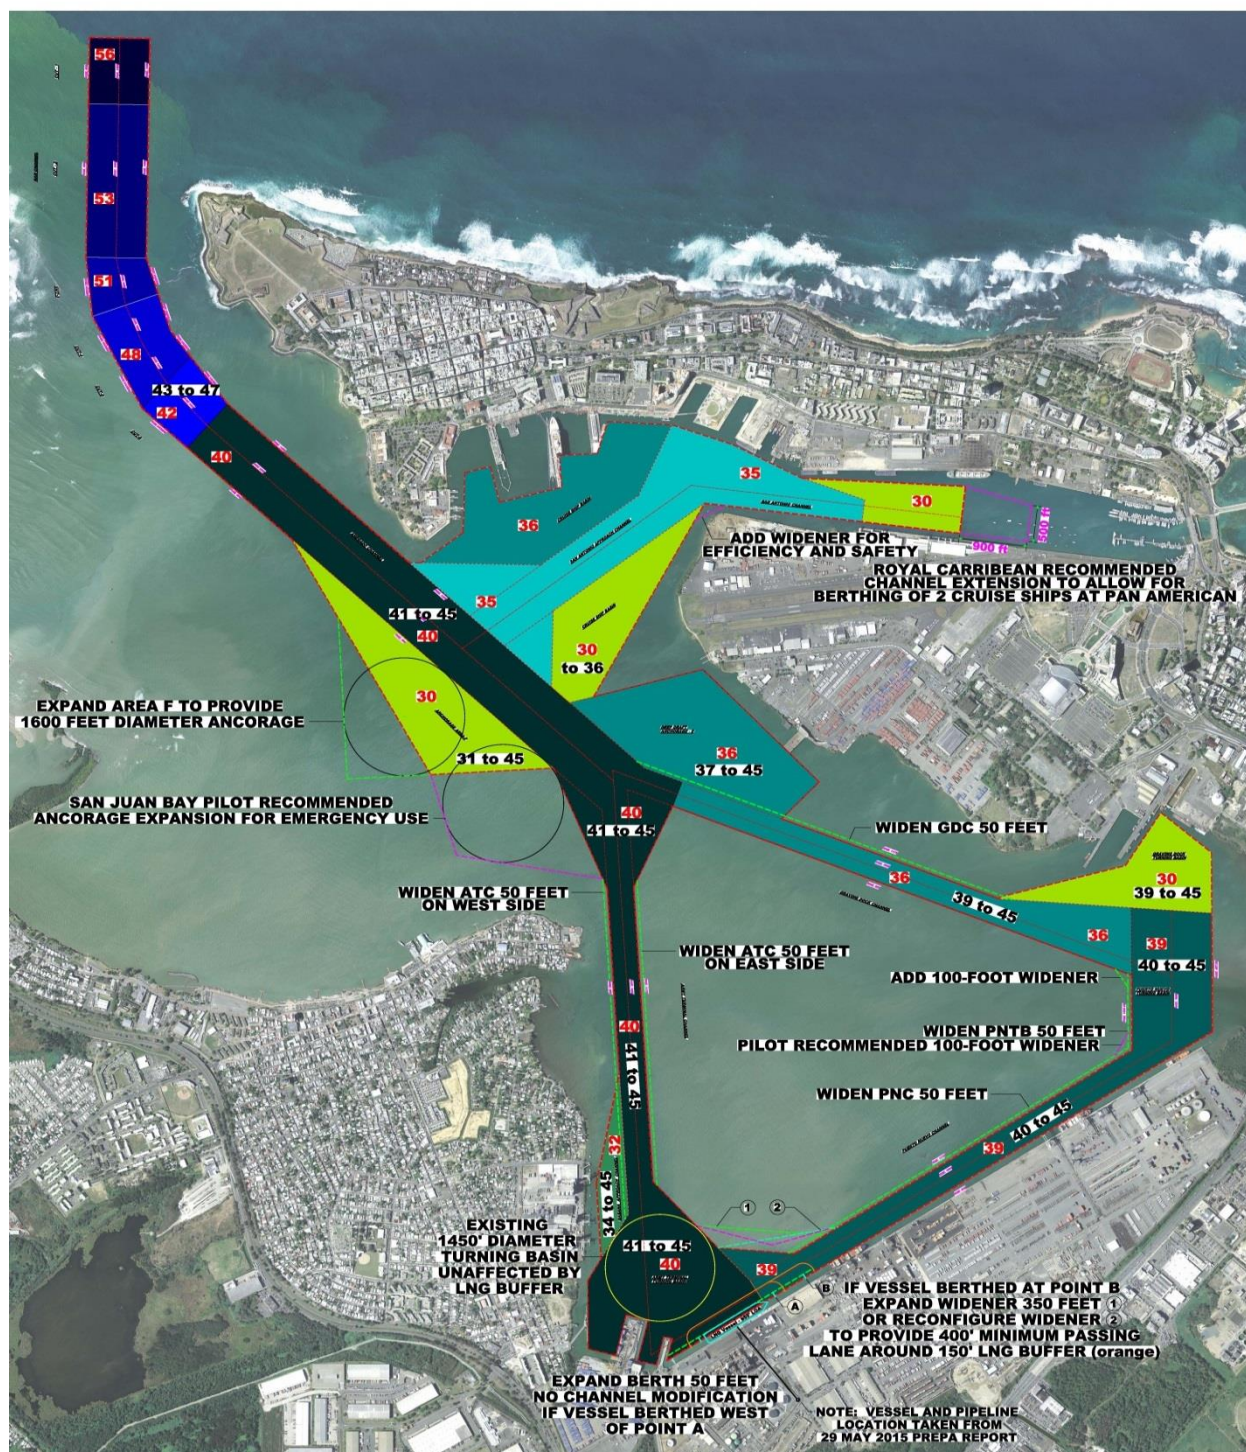
Figure 2. Previously proposed alternatives to the San Juan Harbor improvements showing the widening of the various navigation channels and expansion of the various anchorages.

Previously proposed harbor deepening and widening included all existing channels, designated anchorage areas, Puerto Nuevo turning basin, Army Terminal turning basin, the dredged material placement, and the dredged material placement sites. The work would be performed with various dredges, and the use of explosives may be required for some rock removal (Figure 2). If it is determined that the use of explosives is necessary for certain portions of the channel improvements, additional conservation and mitigation measures may be required to avoid impacts to listed species and sensitive habitats (e.g. manatee conservation measures).

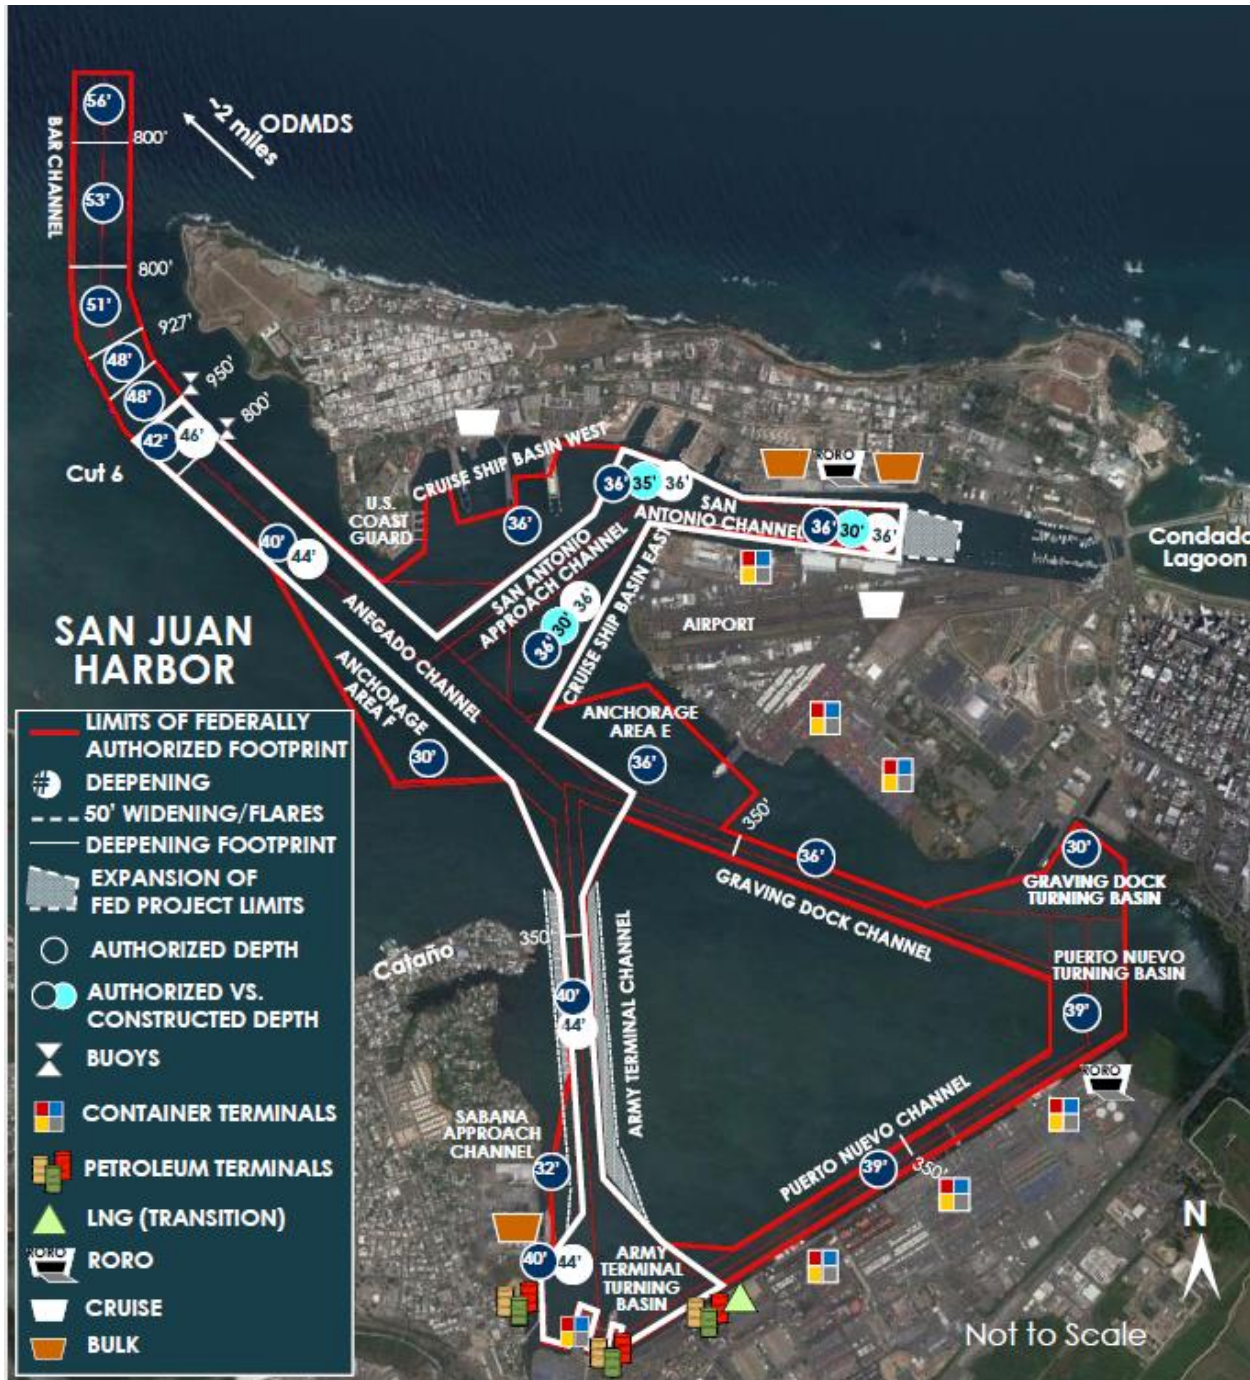
Figure 3. Tentatively Proposed Plan which became the Recommended Plan with reduction in dredging footprint. Only areas outlined in white will be dredged.

The RP has greatly reduced the proposed dredging. Dredging is now limited to the Anegado Channel, San Antonio Channel and Army Terminal Channel and turning basin. Entrance channel Cut #6 will also be deepened. Explosives would not be used; there is the possibility that a hopper dredge could be used instead of the traditional clamshell dredge. Estimates of the quantity of material to be remove are about 2,110,000 cubic yard not including the proposed expansion of Anchorage F. The Corps is considering 24 hour operations to expedite the work.

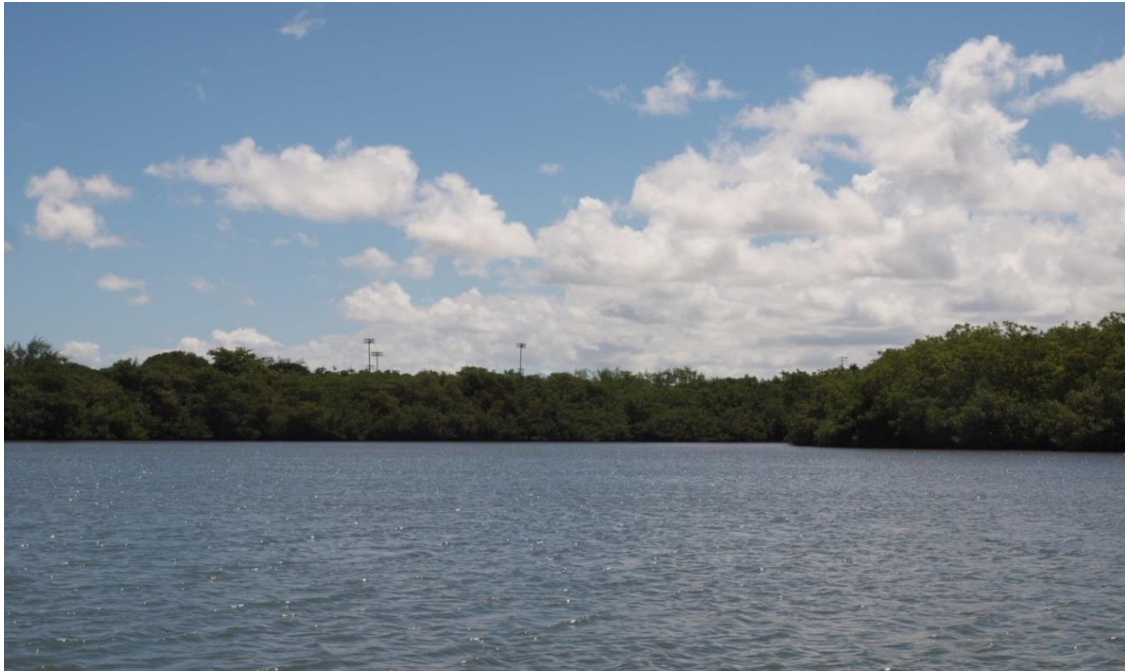
Figure 5. FWS proposed mudflat creation area. Looking south from the Puerto Nuevo Turning Basin the entrance of the Rio Puerto Nuevo is to the right. This quiet cove can be used to deposit dredge material from the nearby Graving dock and Puerto Nuevo Turning basin to create a tidal flat.

The restoration of the Puerto Nuevo mudflats is being proposed by the Service as an additional dredge disposal location within SJB to create emergent wetland habitat with dredge spoil. These mudflats were a series of shoals created at the mouth of the Rio Puerto Nuevo as it discharged into San Juan Bay. This area was once considered a Critical Wildlife Area by DNER. However, navigation projects, flood control projects and port development have all but eliminated this tidal flat area. Prior efforts to partially restore the area resulted in the deposition of excess material, mangroves colonized the site and it is not available to wading birds. With the proposed deepening and expansion of the Army Terminal Turning Basin and Army Terminal Channel, there exists the possibility of using the dredge spoil to create shallow flat areas in front of the existing mangrove fringe. This could be an efficient way of disposing the soft sediments found in the dredging area while at the same time help to re-establish an important habitat for the bay's sea bird and wading bird population, provided that proper intertidal depths can be achieved. About 3-6 acres of tidal flats can be created in the area between the mouth of the Puerto Nuevo and the San Juan Maritime Center (Figure 5).

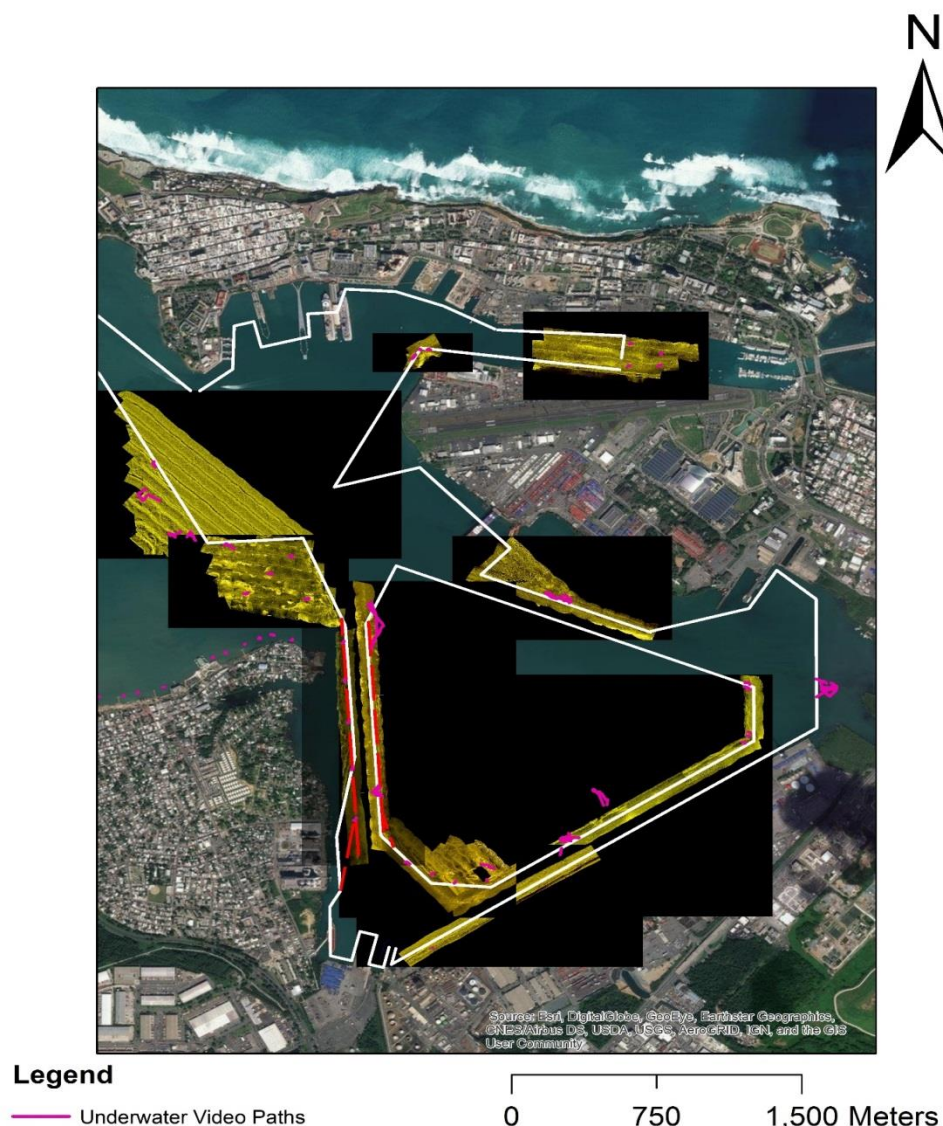
Figure 6. COE side scan sonar and underwater video tracks

The Corps conducted side scan sonar and underwater video surveys between May-December 2016 of the proposed expansion and dredge areas (Figures 6&7). The survey report (DeMarco and Staley, 2017) corroborates the previous NMFS survey for Anchorage Area F and Puerto Nuevo. An estimated 18 acres of SAV (*H. decipiens* and macro-algae) could be eliminated by

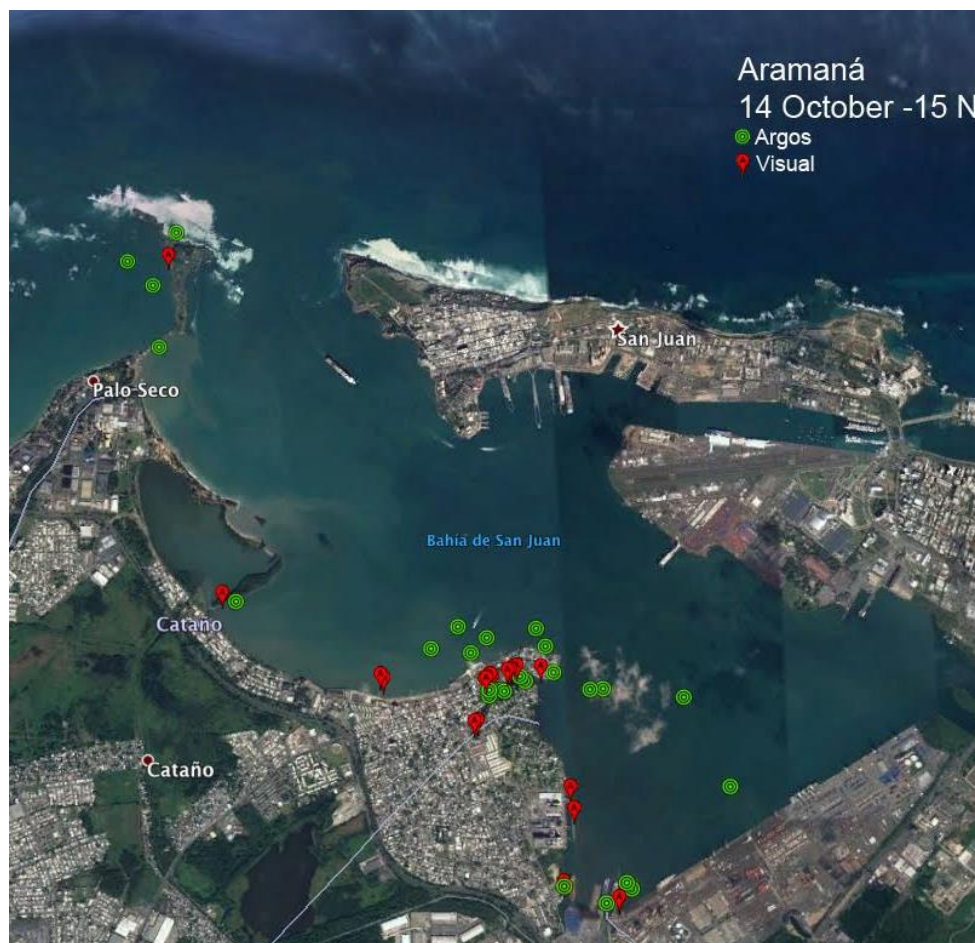
Figure 9: Satellite and visual tracking of the manatee Aramaná, Data provided by the Puerto Rico Manatee Conservation Center.

The specific use of the SJB by manatees has not been studied in detail as opposed to other areas like Ceiba and Guayanilla, where manatees have been captured and released with radio tracking devices (Slone et al. 2006). Together with the PR-DNER and the PR Manatee Conservation Center, the Service has proposed to capture manatees in the SJB area, conduct health assessments tests, and release and follow them with the use of satellite tracking devices. There is current data on one rehabilitated and released sub-adult male manatee (Aramaná) that was using the SJB and was tracked with satellite technology, this data contributes to our understanding of manatee use within the SJB area (see Fig. 9).
