**San Juan Harbor Project, Puerto Rico: Quick Look Video Survey  
Report of the Benthic Communities of San Juan Bay Adjacent to  
Navigation Channels**

**José A. Rivera**

**NOAA, National Marine Fisheries Service**

**February 24, 2016**

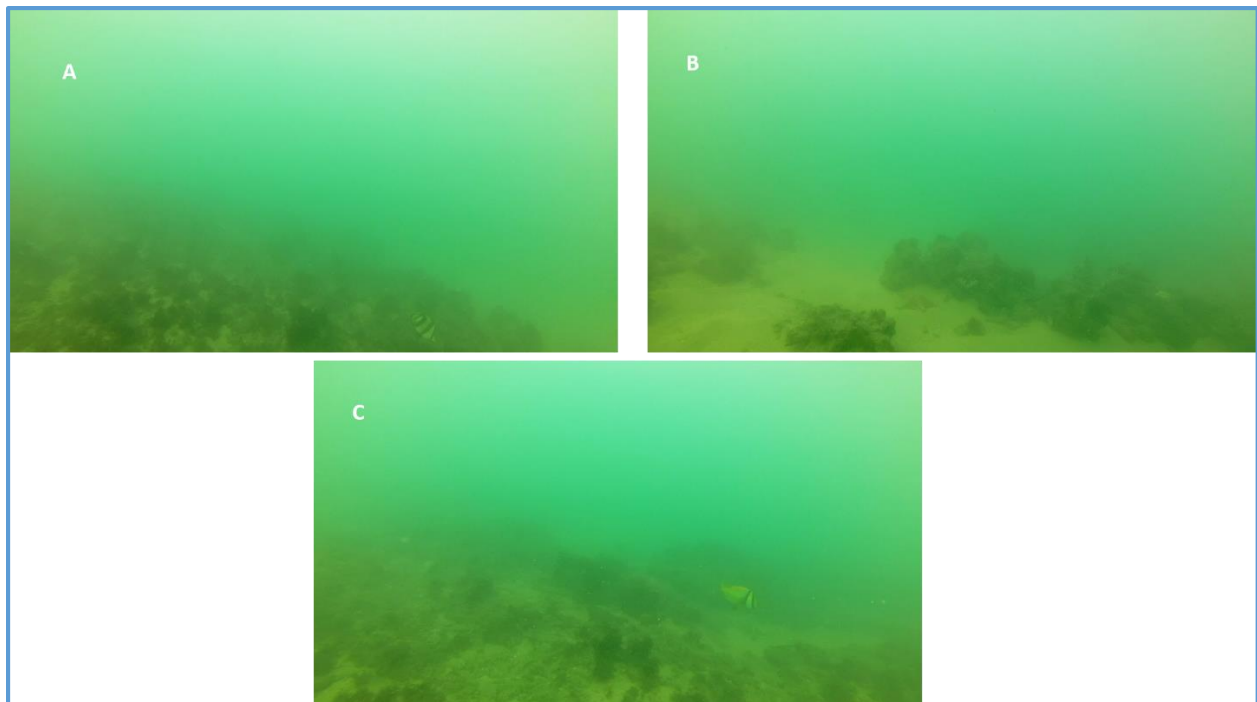
Figure 3. Photos from video transect 206 on Jan. 30, 2016. Depth is 12 ft., turbid. A and B. Algae clumps over limestone and patches of muddy sand. A. The banded butterfly fish (*Chaetodon striatus*) and C. The pork fish (*Anisotremus virginicus*).

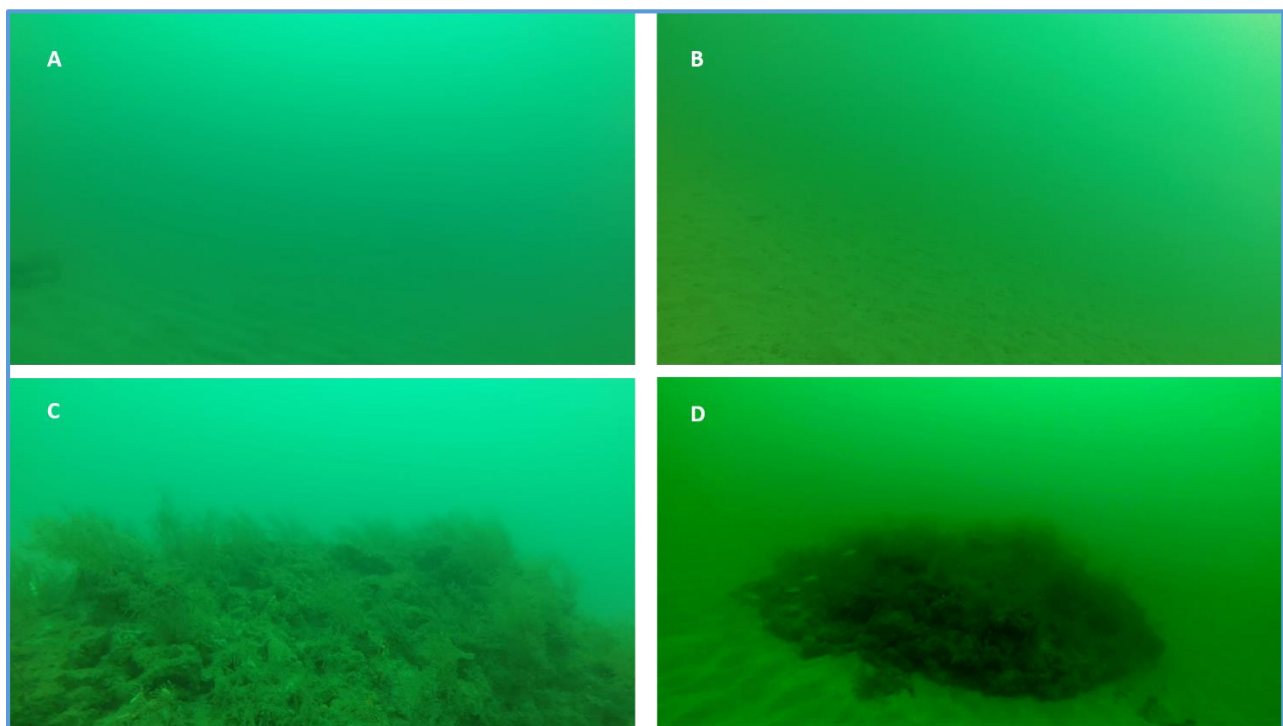
Figure 4. Photos from video transect 209 on January 30, 2016. A and B. Sand. C and D. Algae patch on limestone rock surrounded by sand. Four fish likely to be *Lutjanus synagris* (Lane snapper).

A total of 22 fishes were identified, including very small fish. The list of the species found is in Table 2. Most of the fish were found at video station 210 with a total of fourteen fish. Video station 209 followed in abundance with four fish. The most abundant species was the Lane snapper (*Lutjanus synagris*). Of particular interest was the identification of juvenile hogfish (*Lachnolaimus maximus*).

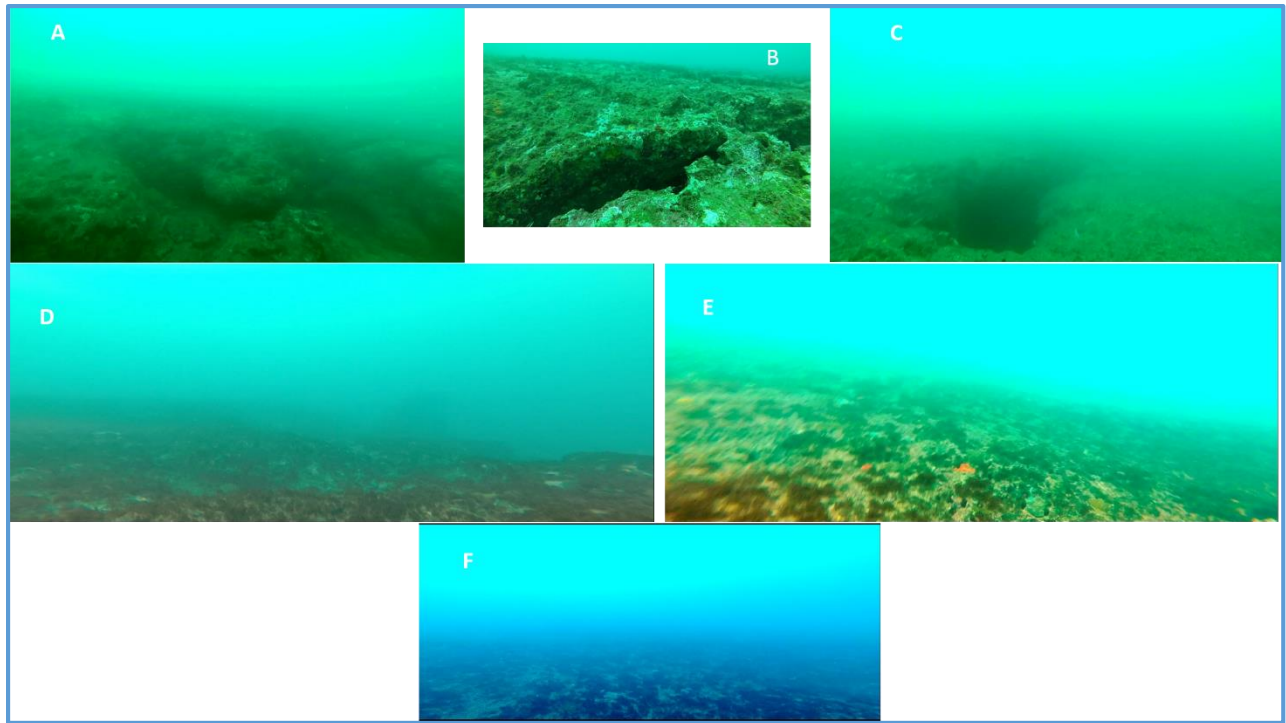
Figure 5. Photos from video transect 210 on Jan. 30, 2016. A, B and C. Limestone ledges and crevices at approximately 17 to 30 ft. depth. These crevices and ledges are inhabited by *Diadema antillarum*, *Thalassoma bifasciatum*, algae and sponges. D, E and F. Algae over limestone substrate.

navigation buoy “G3” the video audio recorded the constant buoy anchor chain noise caused by the sea wave motion. Video stations 210 and 211 exhibited the best water transparency conditions of the entire survey. The worst turbidity was at video stations 215 and 216.

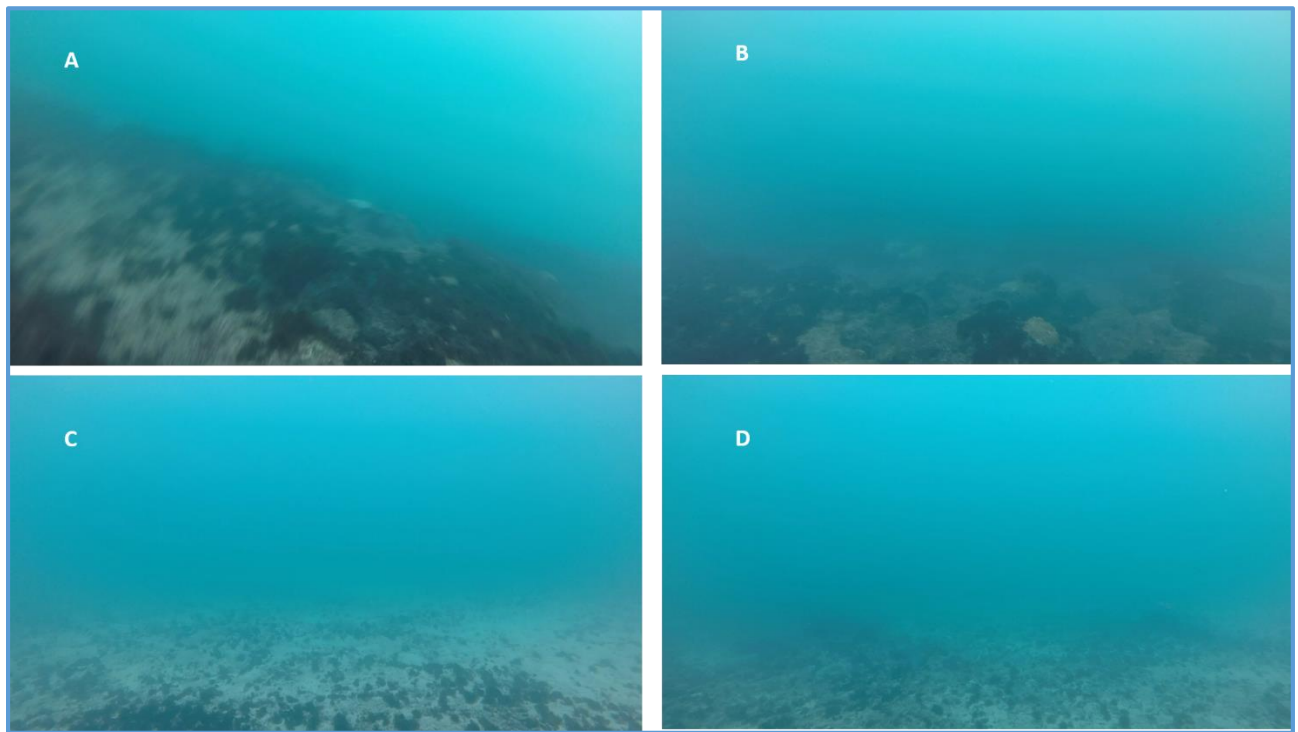
Figure 6. Photos from video transect 211 on Jan. 30, 2016. Depth of 53-54 ft. A thru D. Algae clumps over limestone and some sand. B. *Palythoa caribbearum*.

Only specimens of zoanthid colonies were identified at video station 211 and no scleractinian corals could be detected at any of the stations sampled although limestone hard bottom was found. This does not mean that they are not present. It is likely that they occur at the entrance of San Juan Harbor seaward of video stations 210 and 211.

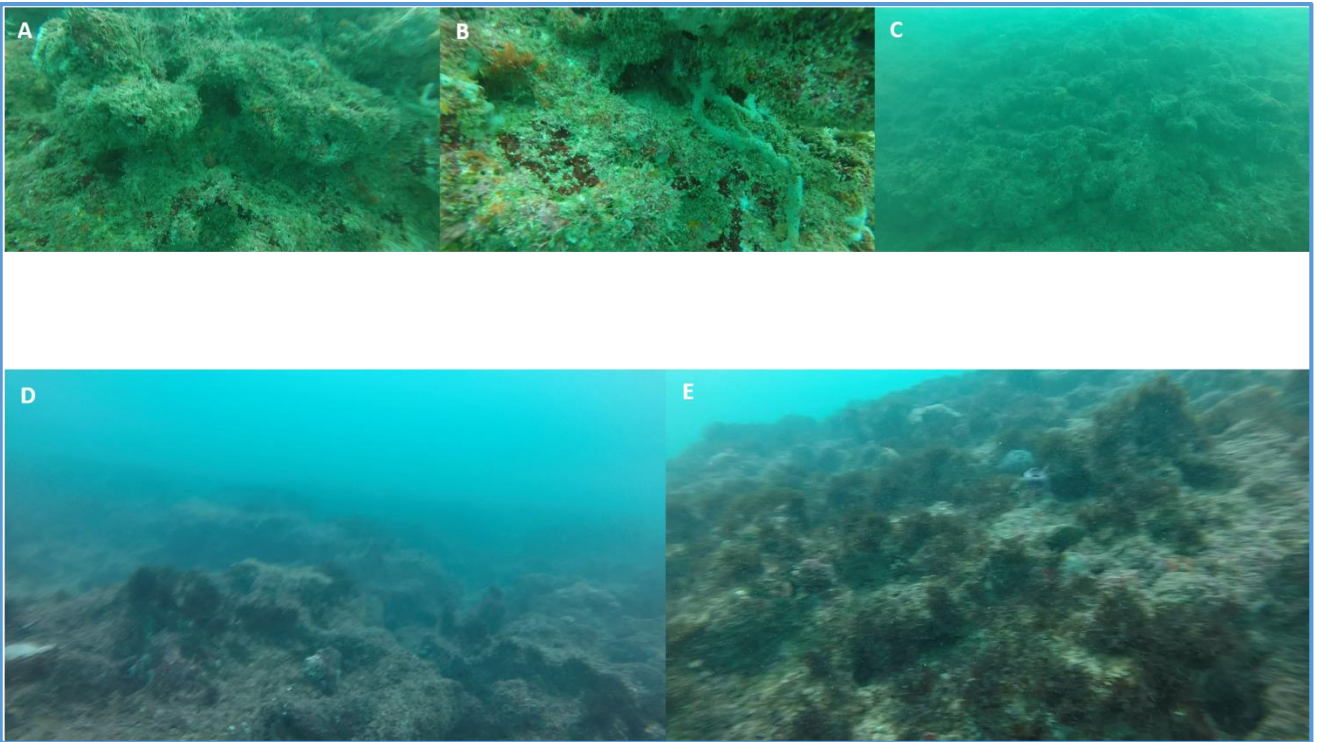
Figure 7. Photos from video transect 211 on Jan. 30, 2016. Depth 16-22 ft. A thru E. Algae and other invertebrates such as sponges over limestone.

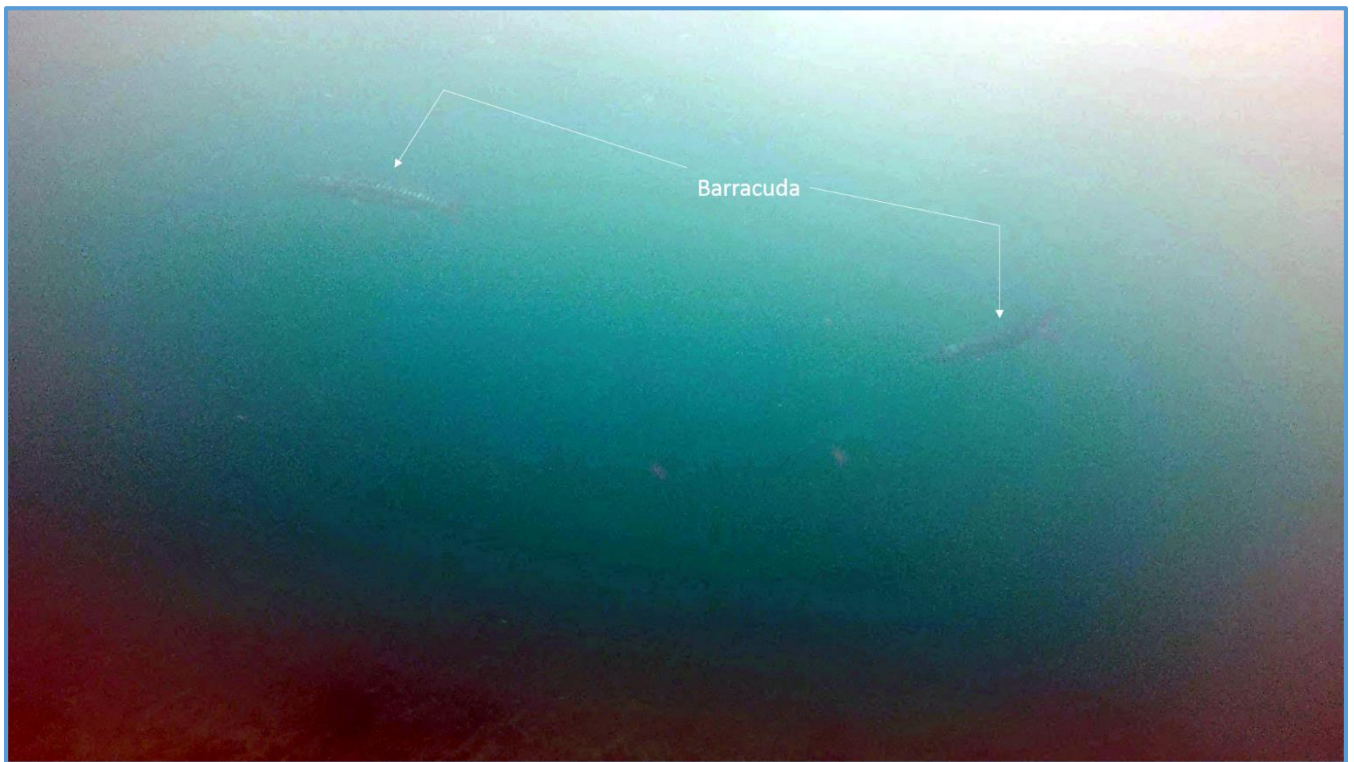
Figure 8. Photos from video transect 211 on Jan. 30, 2016. Two barracudas (*Sphyraena barracuda*) close to the bottom.

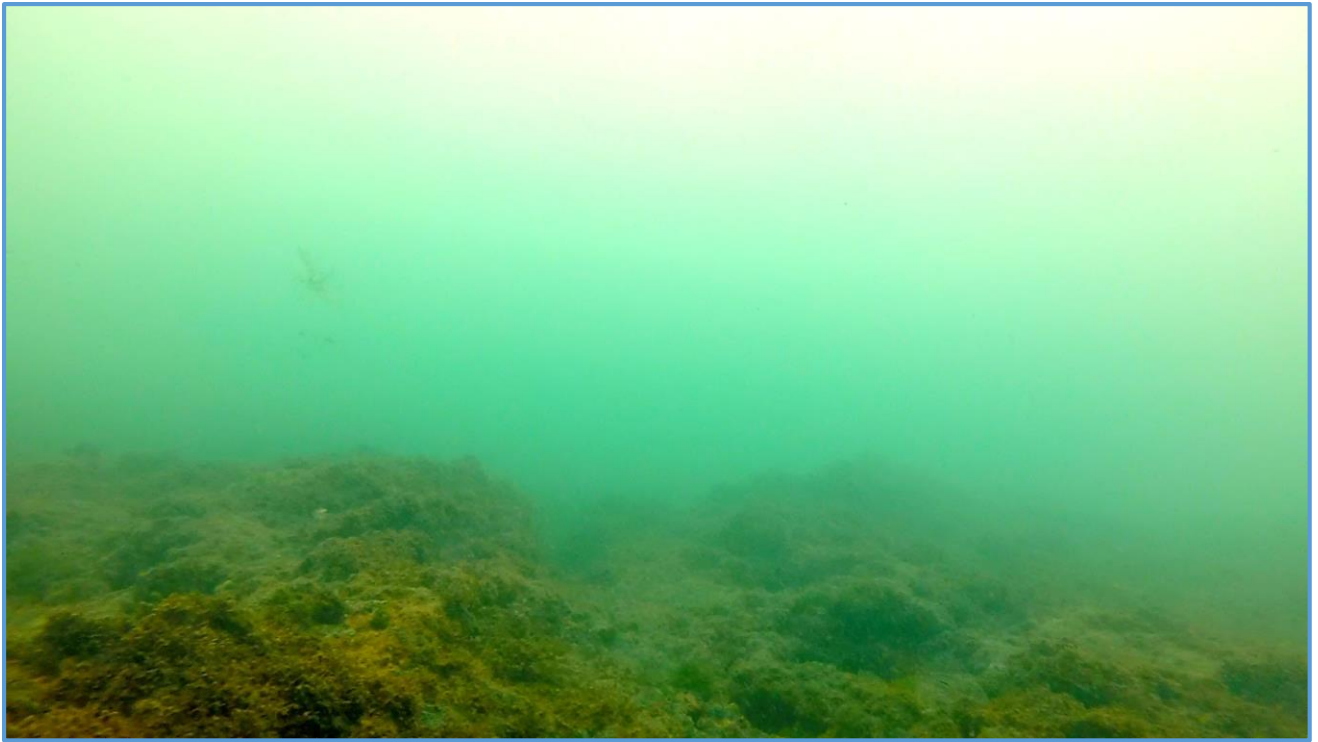
Figure 9. Photo from video transect 212 on Jan. 30, 2016. Depth is 7 ft. Brown algae over limestone.

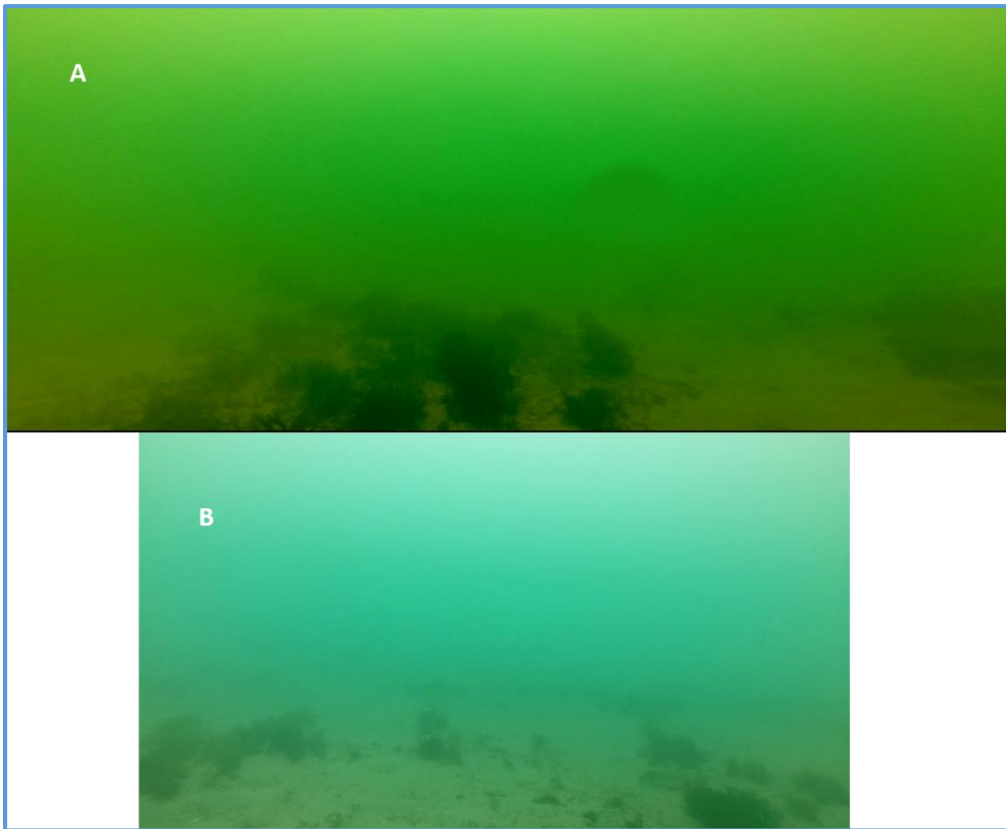
Figure 10. Photos from video transect 213 on Jan. 30, 2016. Depth is 13 ft. A and B. Algae clumps over sand. Turbid.

Two species of Seagrass were identified; *Halophila decipiens* and *Thalassia testudinum*. A small clump of *Thalassia* was present at video station 213 and *Halophila* was present at video station 216.

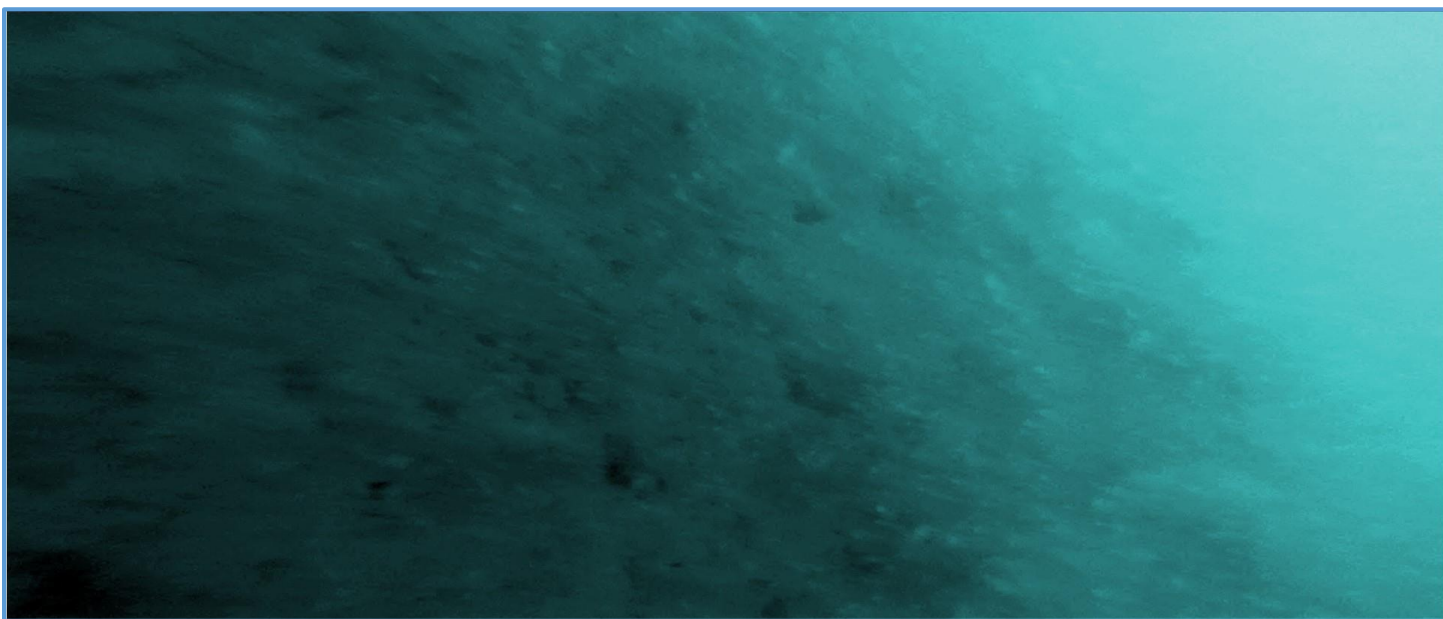
Figure 11. Photo from video transect 215 on Jan. 30, 2016. Mud substrate. Depth is 8-9 ft. Turbid.

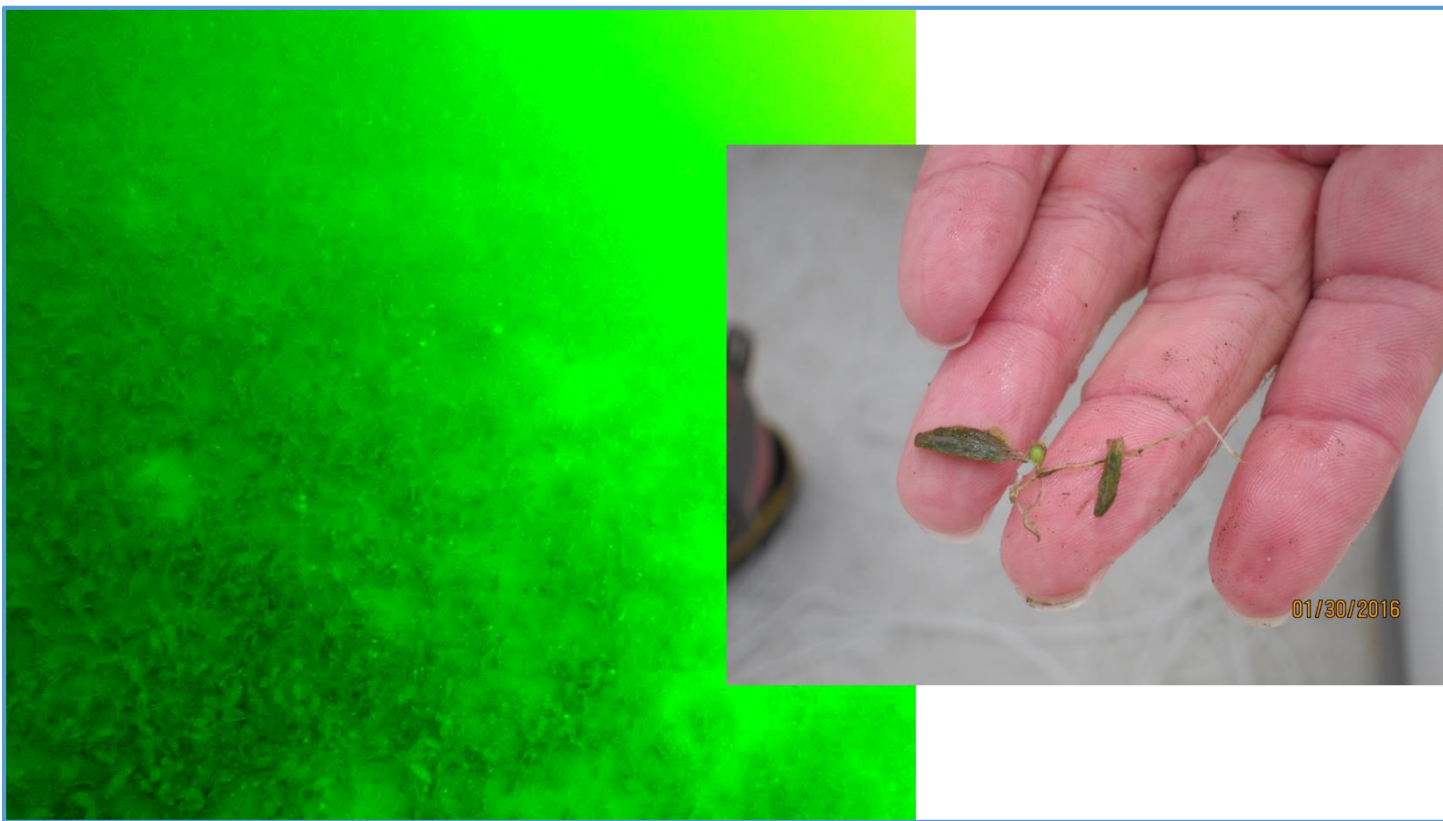
Figure 12. Photo from video transect 216 on Jan. 30, 2016. Seagrass species *Halophila decipiens* with fruit on mud substrate. Depth is 5 ft. Very turbid.

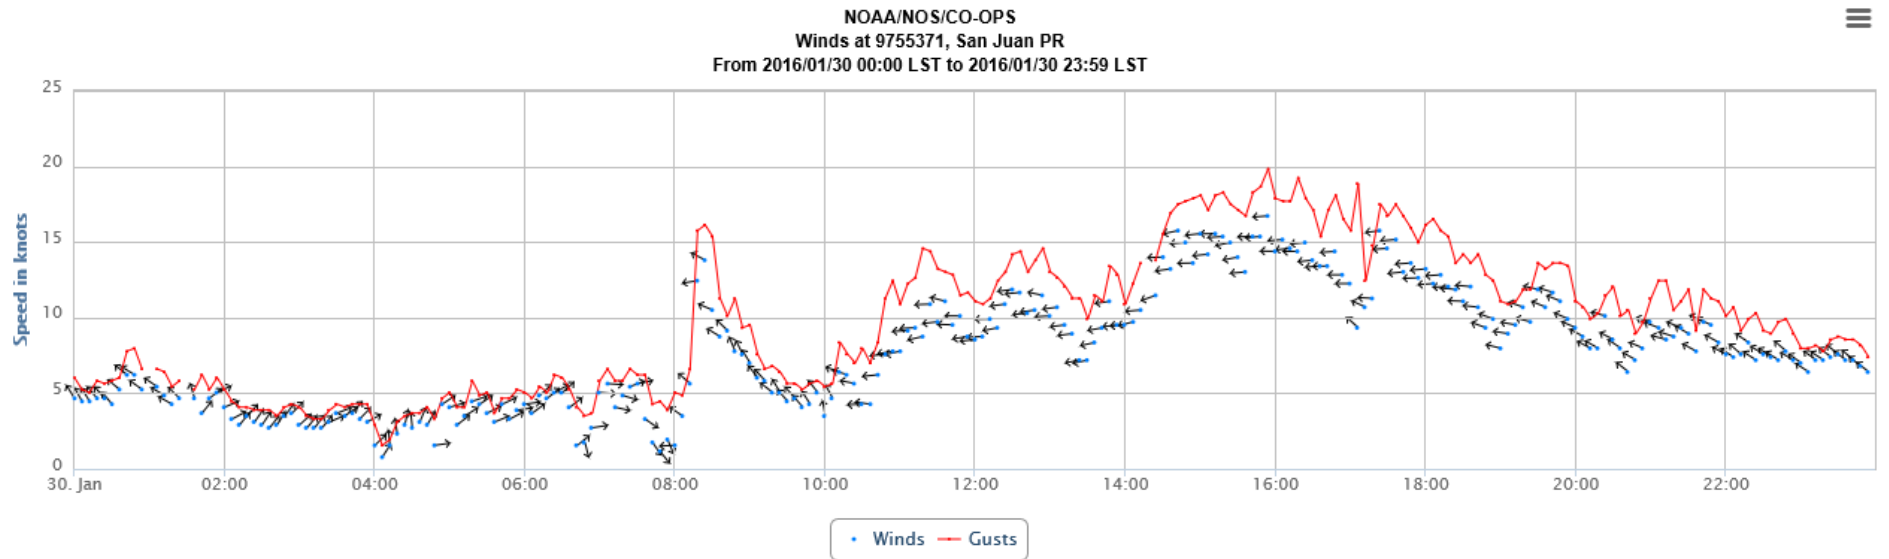
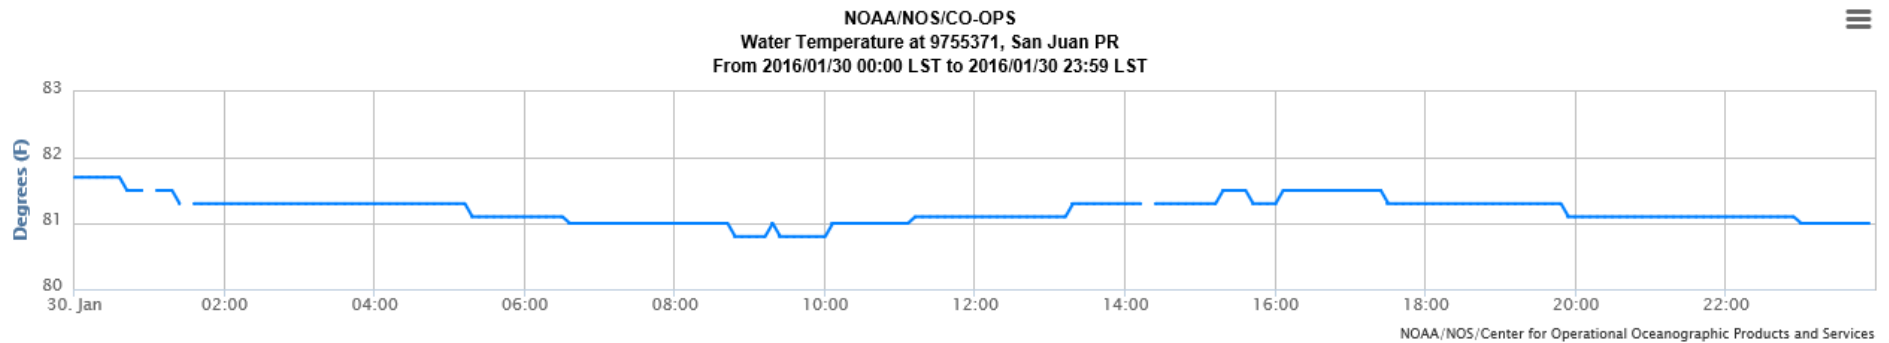
Tide Station located at Latitude 18° 27.6' N, Longitude 66° 7' W.
